## Corrosion monitoring and the environmental impact of decommissioned naval vessels as artificial reefs

### Abstract

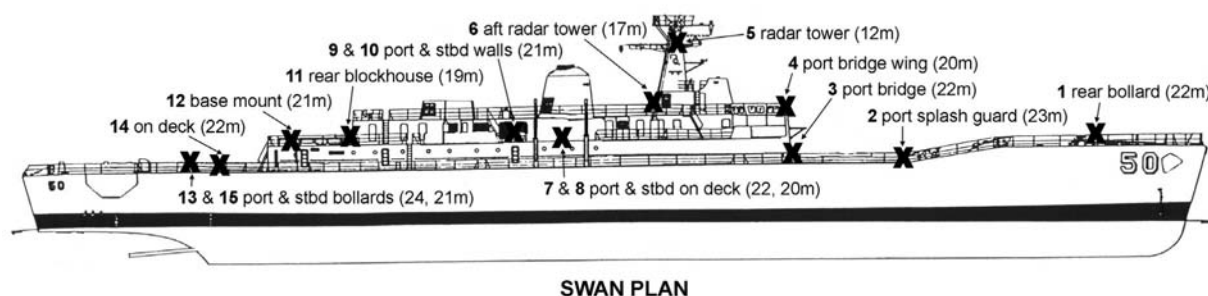
Figure 1. General arrangement plan of the HMAS *Swan* indicating the position of the 15 measuring points on the vessel.

The more positive voltages of the iron alloys measured on the stern (12, 13, 14 and 15) and the bow (1, 2 and 3) suggests that these areas are subjected to a more corrosive environment than the more protected points (7 and 8) located on the upper deck, midships on the vessel. There is a significant amount of scouring around the stern and bow of the vessel, which indicates that considerable water movement is occurring in these areas and increased water movement increases the oxygen flux to metal surfaces thus, in turn, increasing corrosion rates.

The voltage of point **13** at  $-0.368\text{V}$  is very close to the open circuit potential for iron in flowing seawater ( $-0.383\text{V}$ ). This voltage could simply be erroneous but the more likely explanation is the bollard is not in good electrical contact with the rest of the hull. If the latter is the case then this supports the fact that isolated iron artefacts corrode at a faster rate than a large, intact iron structure. This is due to the massive difference in surface area and therefore, the current density is dispersed over a larger area and the corrosion rate of the hull will significantly decrease in comparison to the isolated iron fitting.

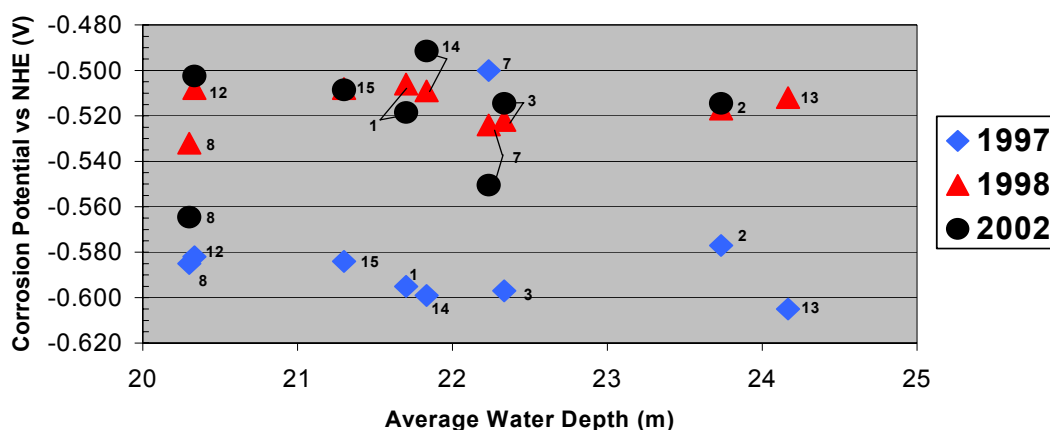
Figure 6. The relationship between the iron alloy corrosion potentials and depth for the *Swan*.

As is evident from Figure 6, there appears to be no correlation between changes in corrosion potential with average water depth on the *Swan* even after four years of submersion. There was also no emergent trend between the aluminium alloy voltages measured on the *Swan* and the average water depths. Similarly, the corrosion potentials for the iron and aluminium alloys on the *Perth* and the *Hobart* showed no correlation with increasing water depth. The lack of any apparent dependence of  $E_{corr}$  on depth is simply a reflection of the inter-connected nature of the structural elements of the vessel and that large sections of the ships are still electrically connected with each other and therefore the voltages expressed do not relate directly to the measurement point. The ships are very much still in the initial stages of deterioration and although there has been some colonisation of the vessel's surfaces, due to the anti-foul present below the waterline of the vessel and the protective paint systems, no significant concretion formation has occurred on the steel hulls during their period of immersion. Therefore, the usual film free iron corrosion mechanism applicable to concreted iron objects where the anodic and cathodic sites are separated by a semi-permeable concretion membrane does not apply to these vessels at this point in time. Experience with the wreck of the *Fujikawa Maru* (1944) in Chuuk Lagoon has shown that this wreck is only now just beginning to have  $E_{corr}$  values that are sensitive to water depth (MacLeod, 2003). The *Fujikawa Maru* has a very similar site orientation to the *Perth* in that it is lying upright on its keel on a flat seabed so it is expected that a decade or two will be needed before any  $E_{corr}$  values on the naval vessels show any systematic behaviour with regard to water depth.

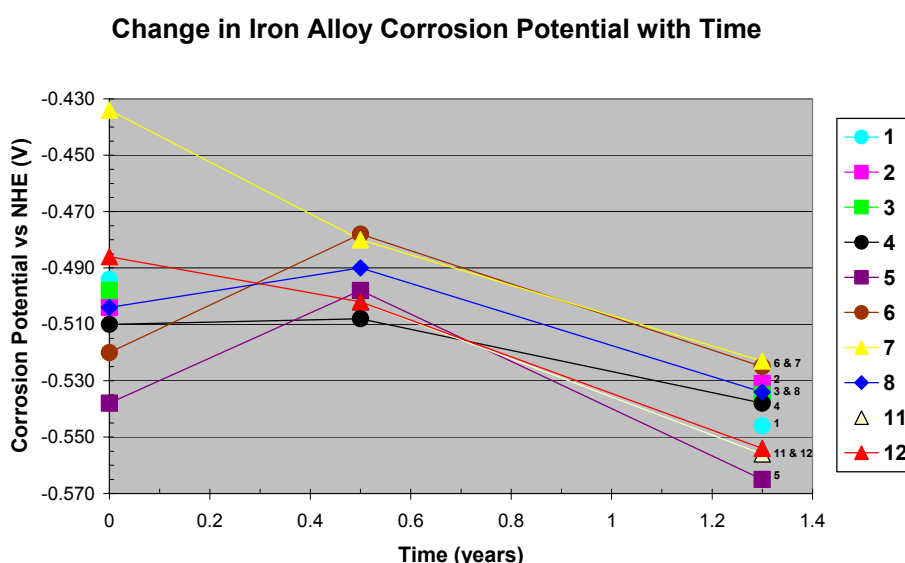
Figure 7. The change in iron alloy corrosion potentials on the *Perth* with time.

The corrosion behaviour of the *Perth* and the *Hobart* for the first six months is very similar, therefore only the *Perth* results will be presented. The aluminium alloy points on the *Perth* are reacting similarly to the iron alloy points (Figure 7) and there appears to be a relatively random scatter of points during the first six months of immersion. The baseline corrosion potential of point 7 on the *Perth* appears to be anomalous and may have been caused by partial electrical connection between the platinum electrode and the bolt during measurement. This random scatter for the *Perth* and the *Hobart* may reflect differences in the amount of sea water penetration through and under the paint film in the vicinity of the measuring points and this, in turn, would lead to a range of dry to wet corrosion cell mechanisms occurring under the paint layers. Therefore, interpretation of any differences between individual data points or sets of the same is not possible for the first six months of immersion. However, after sixteen months there was a small, relatively consistent decrease in the average corrosion potentials of both the aluminium (0.055V) and iron (0.045V) alloy measuring points on the *Perth*, reflecting more effective and uniform penetration of the seawater under the protective paint film and the establishment of a series of localised corrosion cells after a further ten months of submersion.

This decrease in the average voltages after sixteen months could also indicate a relatively small decrease in the corrosion rate of the vessel. This may be caused by the increase in secondary colonisation of the hull and superstructure after this time but there is no significant uniform formation of concretion, which would cause some partial separation of the anodic and cathodic sites effectively slowing the corrosion rate. Therefore, it may be that this decrease in the average corrosion potentials coupled with slightly more acidic pHs at the metal surfaces after sixteen months is more consistent with a slight increase in the corrosion rate due to the development of localised corrosion cells on the vessel as the seawater penetrates the paint layers, causing pitting corrosion of the iron and aluminium under this passive paint film. Unlike film free corrosion mechanisms, with pitting corrosion a decrease in corrosion potential indicates an increase in the corrosion rate.

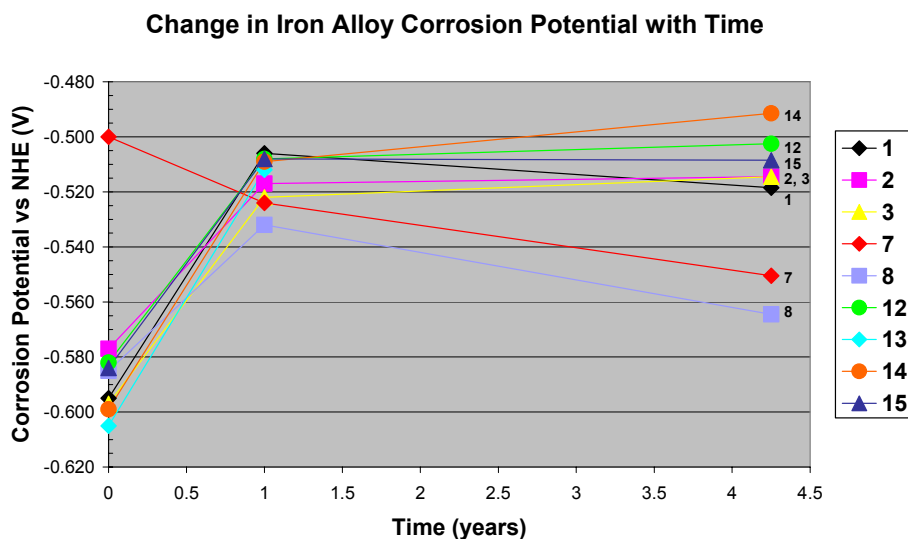
Figure 8. The changes in iron corrosion potentials on the *Swan* with time.

The baseline iron and aluminium corrosion potentials measured four hours after scuttling are indicative of dry cell corrosion mechanisms as the seawater would not have had time to effectively penetrate the protective paint system. Again the voltage of point 7 appears to be anomalous. After one year, the voltages become more positive, similar to the voltages measured on the *Perth* and *Hobart* after the first six months of immersion, reflecting increased deterioration and penetration of the paint barrier with seawater causing a corresponding increase in the formation of localised wet corrosion cells. However, after four years the vessel appears to have attained some form of ‘steady state’ with the local environment and differences in corrosion potentials are becoming more apparent, which may indicate some slow changes in corrosion mechanisms occurring on the vessel.

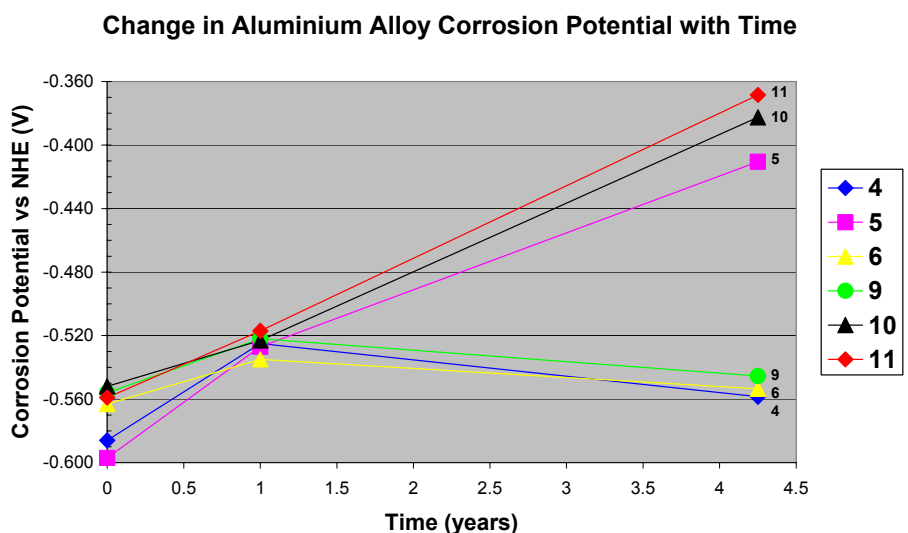
Figure 9. The change in aluminium corrosion potentials on the *Swan* with time.

The aluminium alloy points are reacting similarly to the iron alloys with respect to total water movement and localised turbulence factors. The less negative corrosion potentials of aluminium points **5**, **10** and **11** indicate they are subject to a more corrosive environment than positions **4**, **6** and **9**. Point **4** is positioned on the port side corner of the bridge behind a large splash guard, point **6** is mounted on the wall on the rear of the radar tower and point **9** is mounted on the wall, behind a ladder on the starboard side of the superstructure. All three points are considerably more protected from excessive water movement than the other more exposed positions.
