The delamination of silversulphide layers

R. van Langh ^a, H.A. Ankersmit ^b, I. Joosten ^b

Abstract

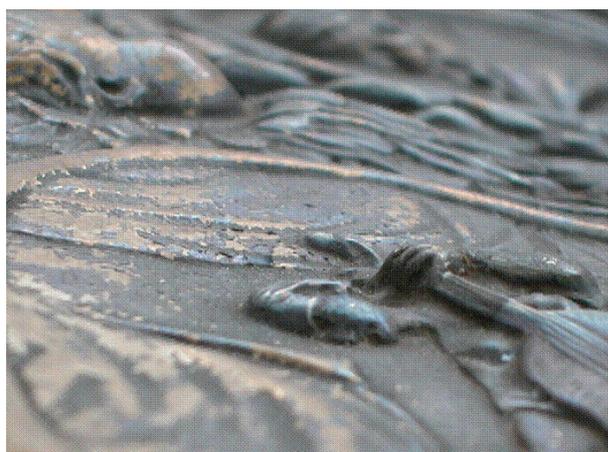
The plate has been in the possession of the Rijksmuseum Amsterdam since 1878. After many years in storage, the surface of the showplate is now covered by a thick black tarnish layer. This is assumed to be mainly silver sulphide (Figure 1A). As can be seen, this layer delaminates at certain places from the metal surface. At places where the silver sulphide is not present the metallic silver surface is observed (Figure 1B). On the revealed silver, new tarnish has been formed at places that were easily reached by H_2S when the tarnish was still present on the surface, *i.e.* the cracks in the Ag_2S . The black lines on the metallic silver in Figure 1B show the outline of the cracks in the original silver sulphide layer.

Figure 1A: Detail of the surface of the showplate showing the thick tarnish layer with delaminating flakes.

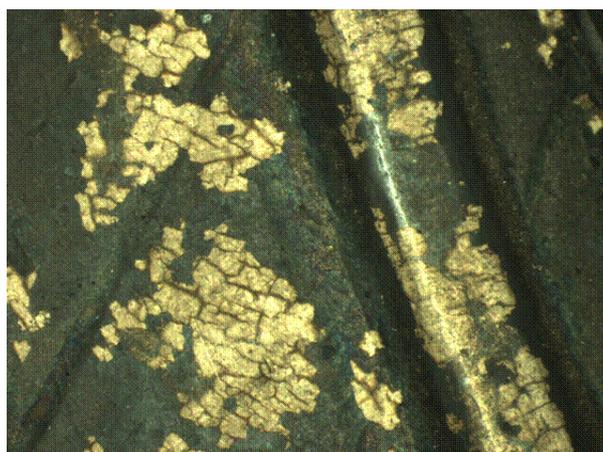
Figure 1B: Detail of 1A, showing the outline of the cracks in the original sulphide layer.

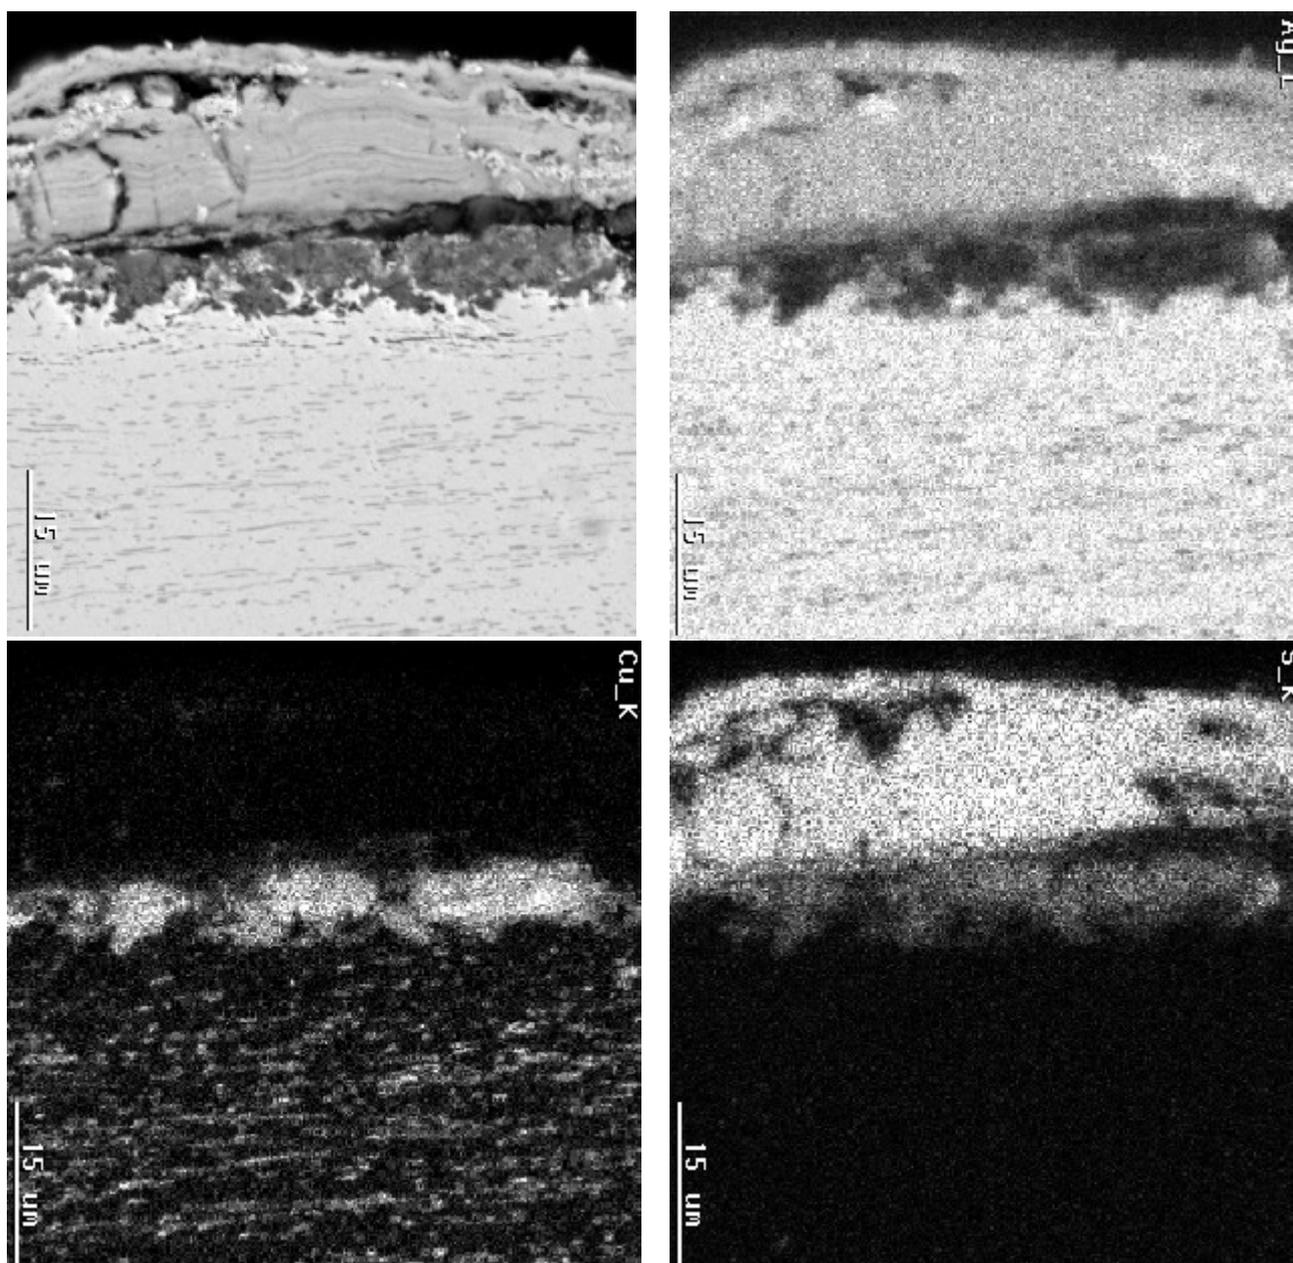
Figure 2: Back scattered image, silver, copper and sulphur mappings of the cross section.

The top layer, being the silver sulphide shows a layered structure with cracks running alongside the original surface and perpendicular to it. Inside this layer several cavities and island of metallic silver can be seen (Figure 2). The thickness of the stratified Ag₂S layer varied from 3.7 to 16.3 μm, but typically a thickness of approximately 14 μm was observed. The thickness of the layers that make the stratification varies from approximately 200 – 1250 nm, giving an average amount of 15 relatively thin Ag₂S layers (see also the back scatter images in Figures 2 and 3). It should be noted that a Ag₂S layer thickness of 140 Å (0.014 nm) appears yellow, while a black tarnish layer is approximately 1400 Å (140 nm) thick (Ankersmit, Doménech Carbó et al. in press). The contrast in the back scatter image within the silver sulphide layer is the result of differences in composition and / or density. Unfortunately the composition of the very thin dark grey lines in between the Ag₂S layers could not be analysed by SEM-EDS. The formation of these layers is not fully understood. However, changing environmental conditions might explain this phenomenon.

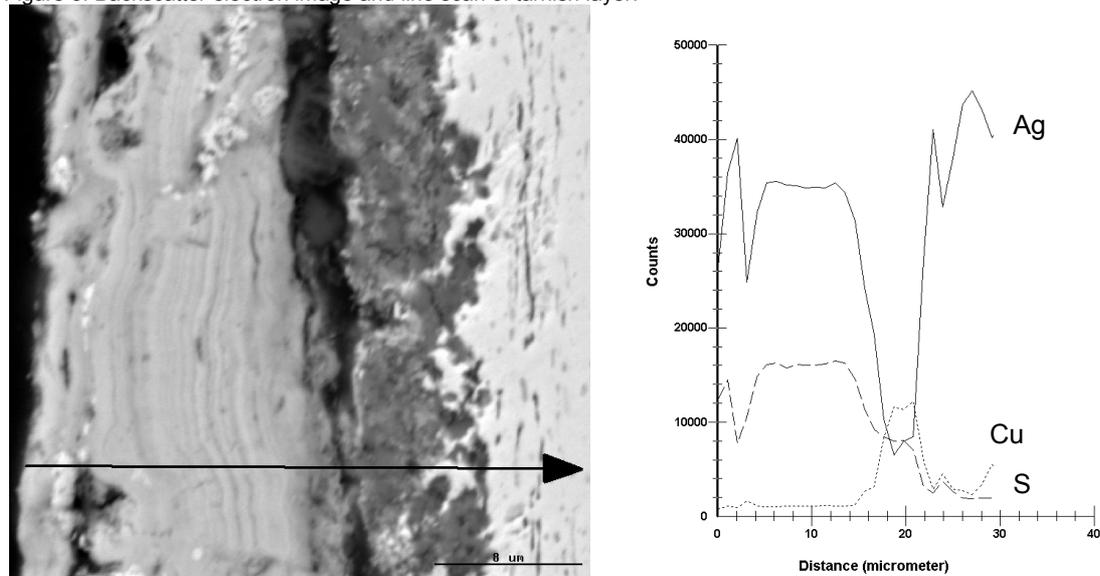
Figure 3: Backscatter electron image and line scan of tarnish layer.

The second layer is rather heterogeneous; showing the presence of conglomerated particles (dark grey in the back scatter image of Figure 3), islands of metallic silver (white phase in the back scatter image of Figure 3), possibly metallic copper (black particles in the back scatter image of Figure 3) and the absence of cracks. The line scan indicates the presence of copper and sulphide, which is supported by the mapping presented in Figure 2. The presence of silver and / or silver sulphide made it impossible to determine the copper / sulphur ratio accurately; it is assumed that CuS is most likely formed (Scott 2002). The metallic silver islands are concentrated near the alloy. Nearer the top all silver has leached out and has been transformed into Ag₂S. The copper enrichment of this layer is remarkable. One might have expected the presence of remnant elongated copper particles (or copper sulphide particles) within the silver sulphide layer (see below for detailed description), which is not the case. The compositional separation of these two corrosion layers, *i.e.* silver sulphide and copper sulphide is not fully understood.
