An approach to the conservation of deeply corroded archaeological silver: the *polos* from Crucinia

A. Archi Olsoufieff^a, O. Colacicchi Alessandri^b, M. Ferretti^{c*}

Keywords: polos, archaeological silver, conservation, gilding, corrosion, Crucinia Metaponto

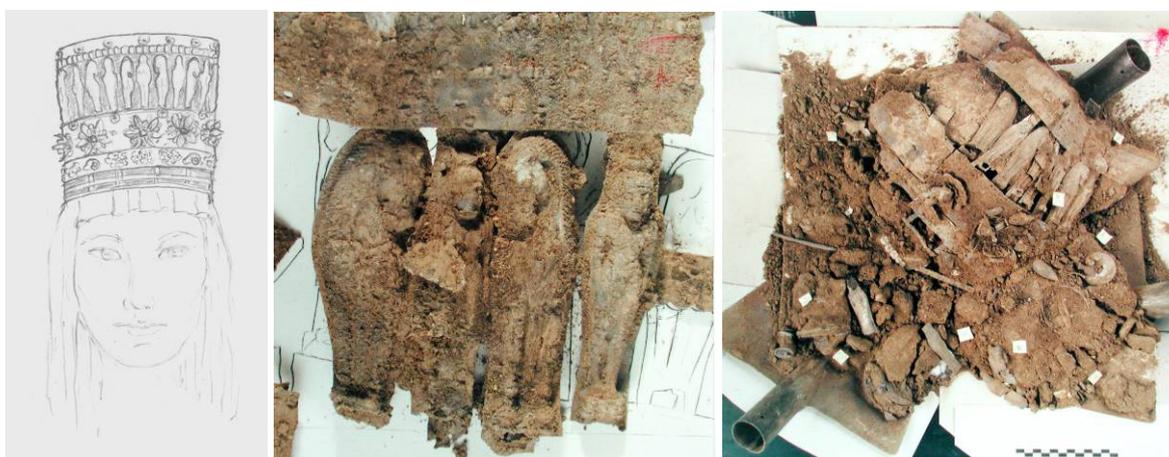
A preliminary analysis of the object's conservation conditions found serious deterioration, due to the burial conditions (Figure 1, centre) but also caused by the urgency with which it was rescued (Figure 1, right) and to the incompleteness of previous cleaning treatments. The observed alterations include:

- the almost complete mineralization and the consequent fragility of the laminae;
- the presence of complex corrosion patterns involving thick layers of silver chloride hiding the gilding, sometimes alternated to calcium carbonate, also thick and adherent to the gilding;
- the distortion of some fragments and the incompleteness of the left-hand side, due to the pressure of the deceased preiress's head;
- the extreme and diffused fragmentation;
- the loss of the organic support material and of some joining elements.

Figure 1. Graphical interpretation of the *polos* (left); detail of the conservation conditions of bands A and B after the rescue (centre); the *polos* during the urgent rescue (right); photographs: courtesy of the Soprintendenza Archeologica della Basilicata.

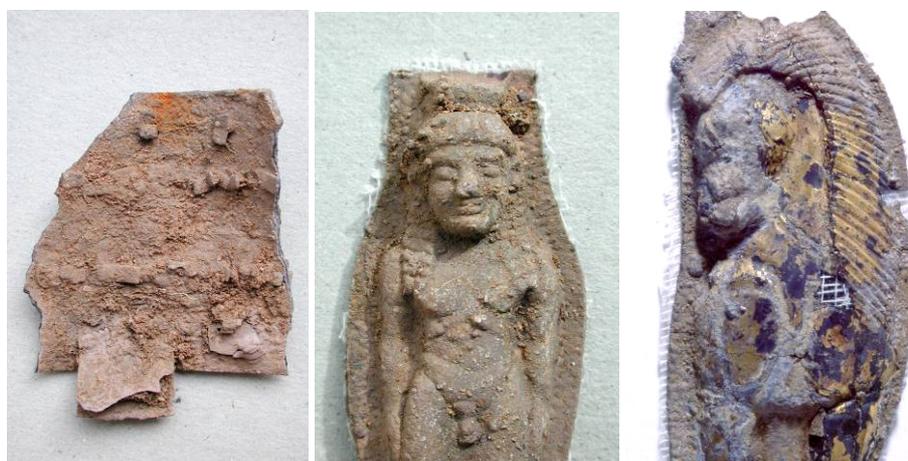
Different cleaning strategies were considered, with special regard for mechanical and chemical methods; these had to be suitable to remove the thick layers of silver chloride that hid most of the gilded surfaces, thus preventing their readability (Figure 3). In this phase considerable support was provided by radiographies and scanning electron microscope investigations.

Figure 3. Details of the corrosion products and deposits covering the fragments (left and centre) and of the gilding conditions (right).

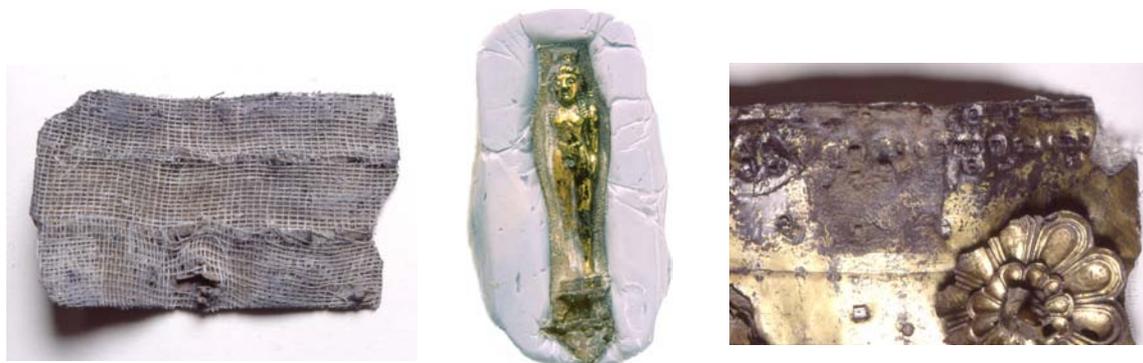
Figure 4. Temporary back-veiling of the fragments (left); piece supported by a silicone rubber mould during mechanical cleaning (centre); result of the mechanical cleaning with respect to uncleaned areas (right).

- before mechanical cleaning, the fragments were temporarily consolidated by back-veiling with cotton gauze stuck with acrylic resin (Figure 4, left); silicone rubber moulds were made to support the pieces and avoid concentrated stresses during mechanical cleaning (Figure 4, centre);

- removal of the thick layers of silver chloride and calcium carbonate by means of mechanical cleaning of the surfaces, carried out with surgical blades, abrasive micro-spheres mounted on a prosthetic drill, soft brushes (Figure 4, right). It was preferred to leave part of the silver chloride on the most fragile edges of the laminae;

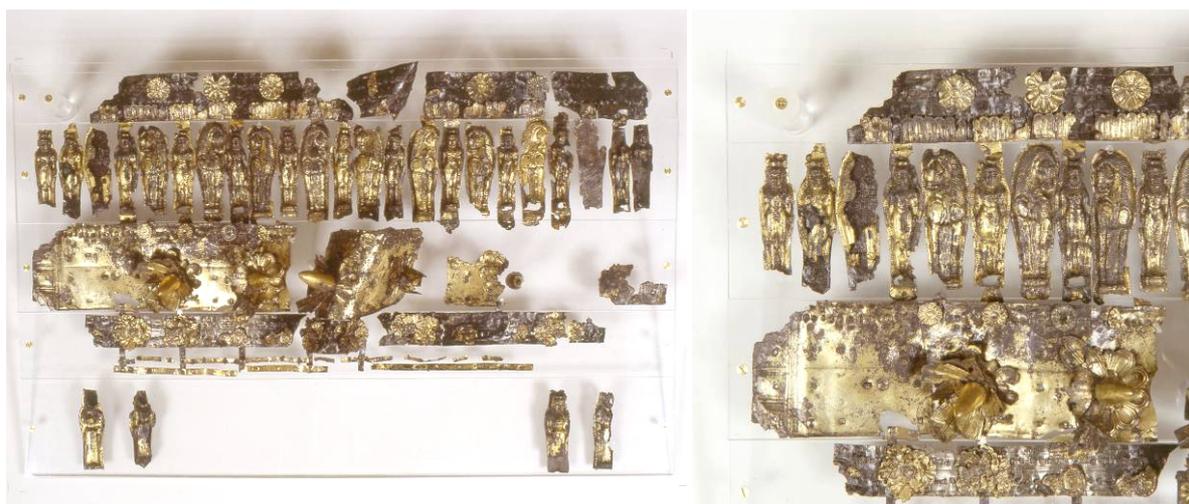
Figure 5. Polos recomposed on the support system: full view (left) and detail (right); photographs by P. Rizzi.

The lay-out resulting from the final hypothesis is shown in Figure 5. Given the deformations in the central part of the *polos*, it was impossible to arrange the fragments on a support structure that would suggest a headgear. It was therefore decided to set the pieces on four separate plexiglass bands, provided with suitable templates to support the distorted parts; all the elements were attached to the plexiglass by nylon threads; an inclined plexiglass plane supported the whole.

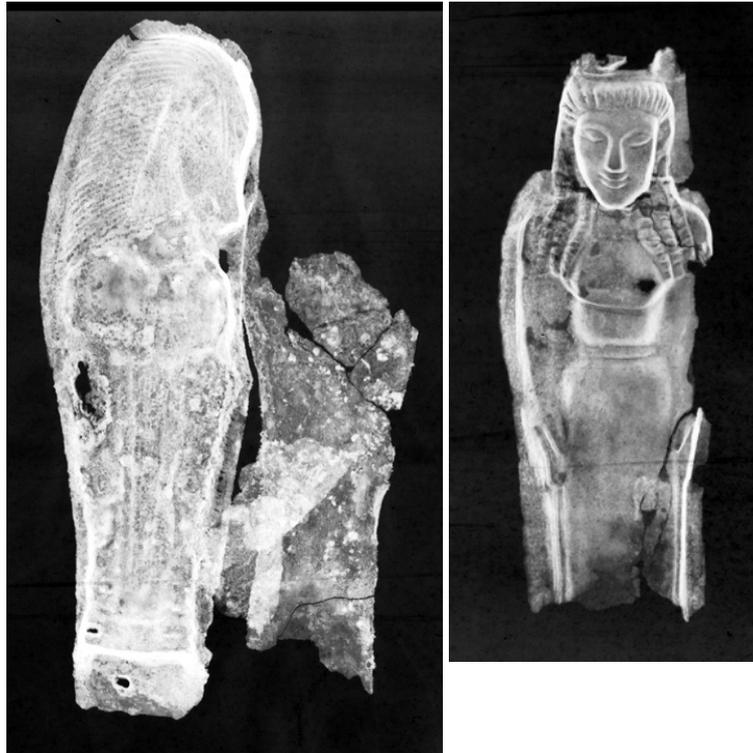
the radiographic detail of one of the horses and part of the adjacent lamina: cracks and areas of deep corrosion are clearly visible. The radiographs also show (right) the details of the shape of a *kore*. Figure 7 shows different fragments of band D: the top-most fragment is relatively uncorroded and shows numerous staples – used to join the lamina to the organic support – in their seats. A flower and some empty loops are also visible; the band at the bottom of the image is more corroded and cracked; it only has empty loops. Besides the usual cracks, areas of deep corrosion and staples, Figure 8 shows an interesting – digitally processed – detail of a loose decoration element hidden behind a flower on band C.

Figure 6. X-ray images of one of the horses with part of the adjacent lamina (left) and a *kore* (right).

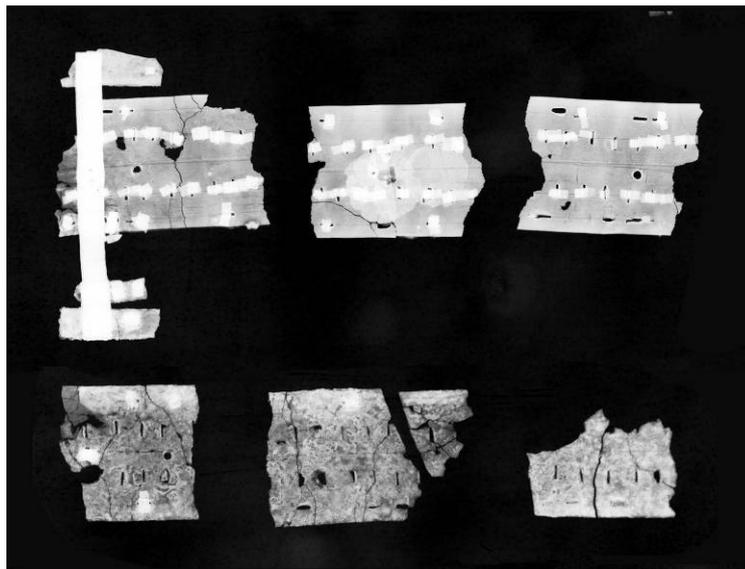
Figure 7. X-ray image of different fragments of band D.

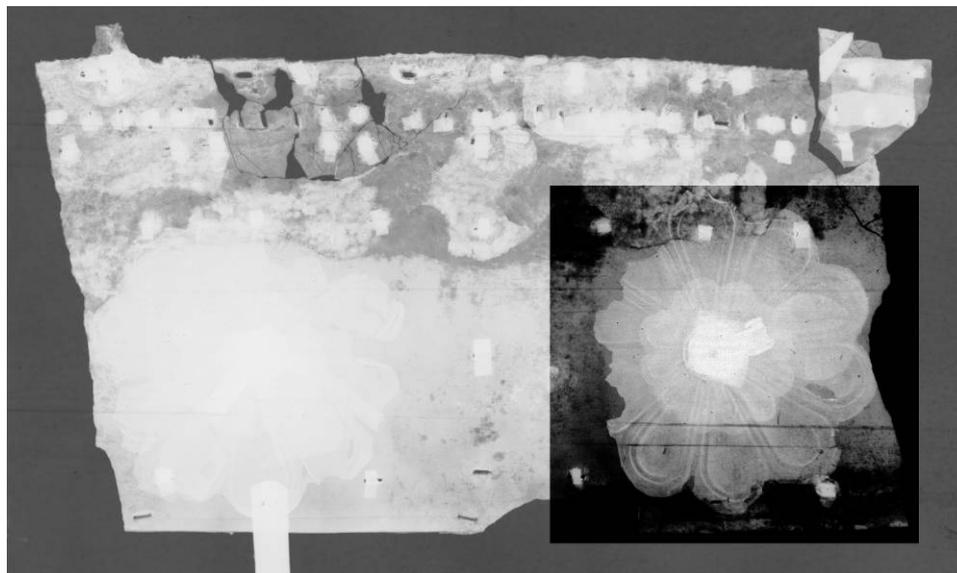
Figure 8. X-ray image of band C; digital processing of a detail showing a flower that hides a loose rosette behind the corolla.

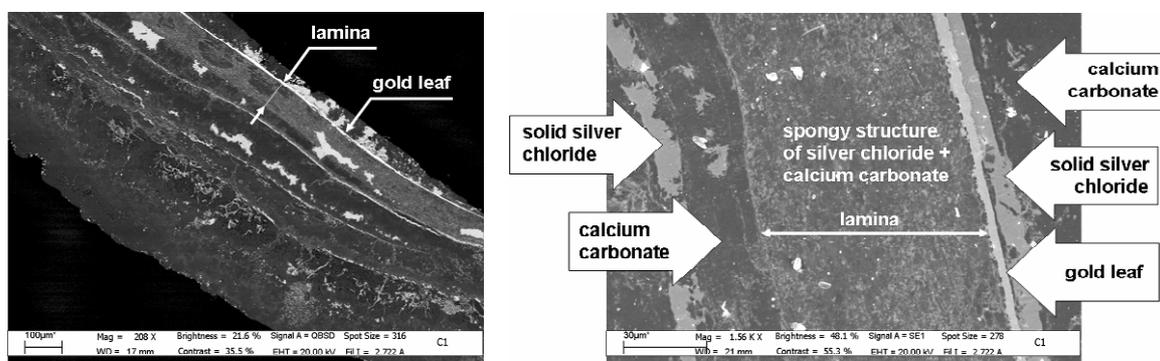
Band C, half-rosette, sample C1: Figure 9 left shows the corrosion pattern typical of this object: below the gilding, the lamina is entirely mineralized; further alternately stratified corrosion products (silver chloride) and deposits (calcium carbonate) grow on the non-gilded side of the lamina; the stratification is possibly related to the periodical floodings and droughts experienced in the tomb. A detail of the mineralized lamina is shown on the right: from the surface (right) inwards (leftwards), it is possible to observe:

- a deposit of calcium carbonate;
- a solid layer of silver chloride, just above the gold leaf;
- the gold leaf;
- just below the gold leaf, a spongy structure of silver chloride and calcium carbonate, corresponding to the original silver lamina; the calcium carbonate may precipitate due to the cathodic reduction of oxygen to hydroxyl in the presence of calcium ions and carbonic acid (Marabelli, 1995). Measured in different parts of the spongy structure, the relative concentration ratios of Ag, Cl and Ca appear reasonably constant;
- calcium carbonate alone and a solid layer of silver chloride.

Figure 9. Band C, half-rosette, sample C1, cross-section: backscattered electron images of the corrosion pattern (left) and a detail of the lamina (right).

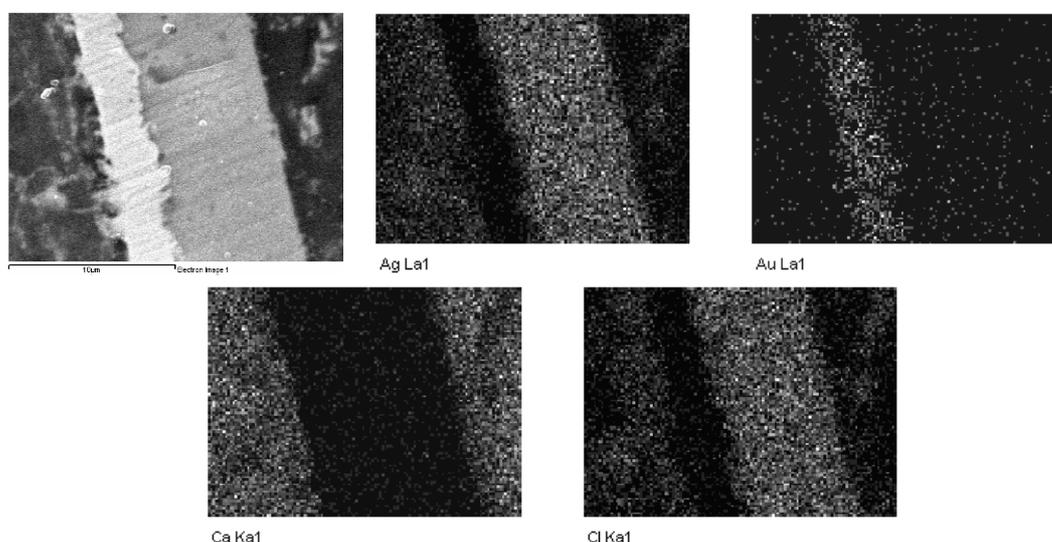
The described corrosion structure and the concerned elemental maps are shown in Figure 10 at higher magnification: the leaf thickness is about 3 microns, no Hg is detected in any part of the cross-section.

Figure 10. Band C, half-rosette, sample C1, cross-section: backscattered electron image and elemental maps of the leaf and its immediate surrounds

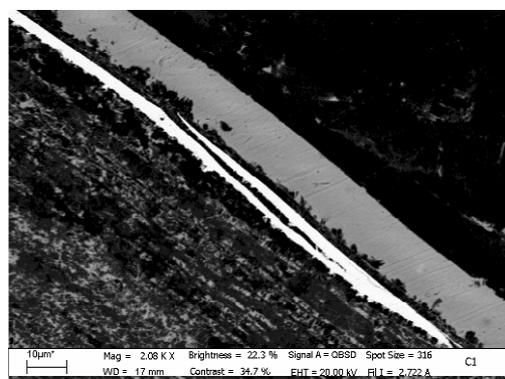
Further information about the gilding technique (provided by Figure 11) that shows the partial detachment between two gold leaves in an overlapping zone; this indicates the exclusion, with reasonable certainty, that the so-called diffusion bonding (Oddy, 1993) ever took place. It is likely that the gold leaf was applied after the embossing and no heating was carried out.

Figure 11. Band C, half-rosette, sample C1, cross-section: backscattered electron image showing the detachment between two gold leaves in an overlapping zone.

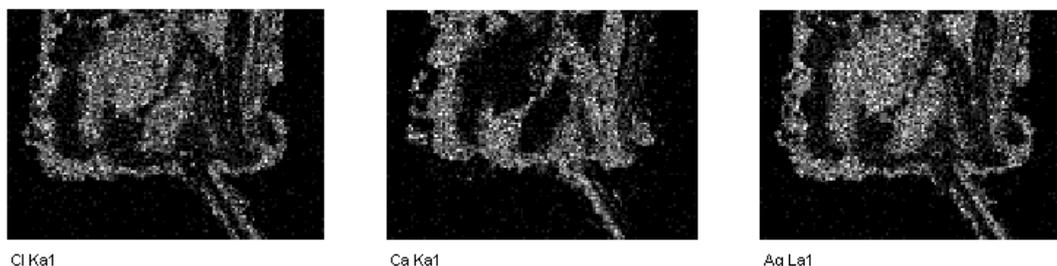
Band G, staple, sample C2: Figure 12 shows the cross-section of a staple and the surrounding lamina, the concerned elemental maps are shown as well. Similarly to sample C1, it is possible to observe the complex corrosion pattern made of solid silver chloride and the spongy structure of silver chloride and calcium carbonate.

Figure 12. Band G, staple, sample C2, cross-section: backscattered electron image and elemental maps of a staple and the surrounding lamina.

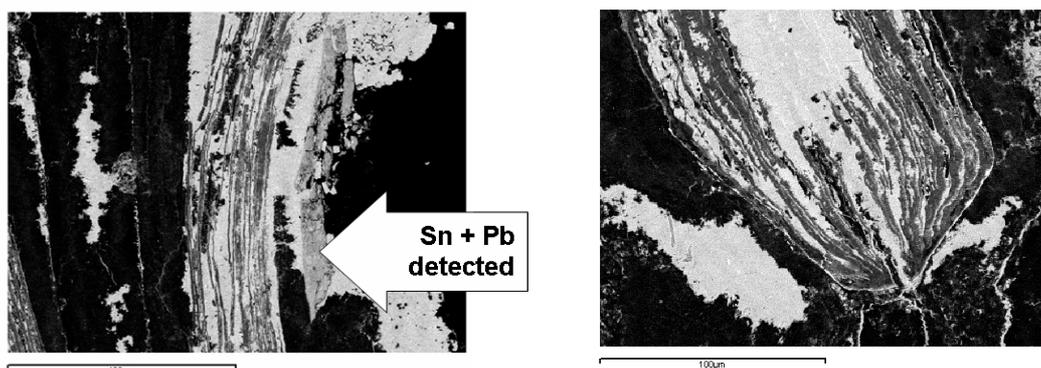
Microanalysis shows the presence of Pb and Sn on the head of the staple (Figure 13, left). The method of joining some decorative components to the bands still remains unclear, as no joining elements were found; therefore it is possible that these are the remains of soft solder used for joining. Several areas of the sample (Figure 13, left and right) show a peculiar structure – whose nature is not understood at the moment – made by the alternate overlapping of numerous gold layers and silver chloride layers, the former being thinner than the gilding.

Figure 13. Band G, staple, sample C2, cross-section: backscattered electron image of the staple’s head (left) and the tip of the wing (right).

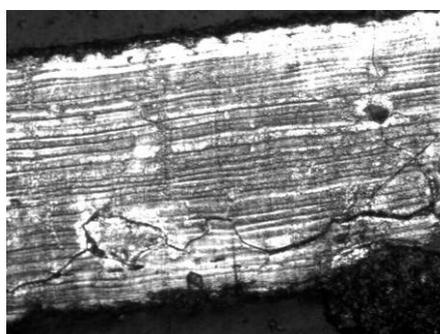
Band D2, sample C3: the sample is almost uncorroded, the microanalysis shows almost pure silver, in particular there is no alloying copper. In the optical microscope view the etched cross-section shows the slipping planes due to cold-working (Figure 14, AB2 Art, 2001).

Figure 14. Band D2, sample C: optical microscope image of the etched cross-section showing the slipping planes due to cold-working.

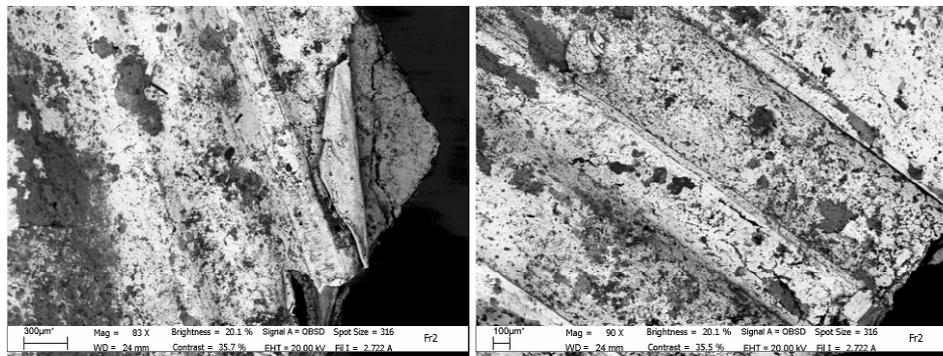
Band C, fragment of flower: the images (Figure 15) are indications of the bad conservation conditions, frequently found on the gold leaf. They show the leaf edge detached and folded with the underlying silver chloride (left); and the working marks, left in the metal to assist the adhesion of the leaf to the substrate (right).

Figure 15. Band C, fragment of flower: backscattered electron images of the gold leaf showing a detachment (left) and the working marks (right).

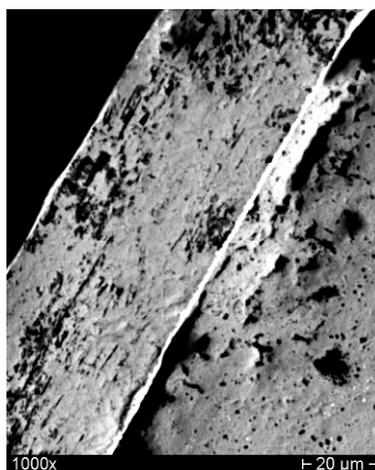
Band C, petal of flower, sample C5: Figure 16 shows an example of lamina gilded on both sides (AB2 Art, 2001).

Figure 16. Band C, petal of flower, sample C5: backscattered electrons image of a lamina gilded on both sides.
