Surface analysis of corroded silver coins from the wreck of the *San Pedro De Alcantara* (1786)

I.D. MacLeod^a, E. Schindelholz^{b1}

Abstract

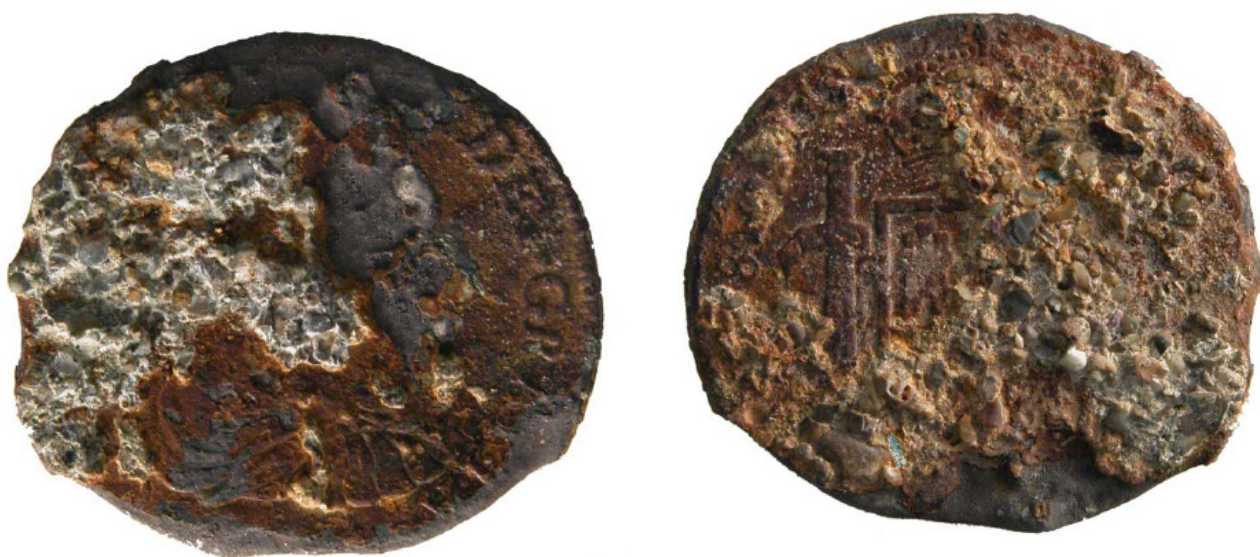
The degree of preservation of the recovered coins related to their location on the wrecksite. Coins 4324, 4325, 4327 and 4331, which were found buried under 15cm of coarse sediment, have more or less retained their original dimensions. Coins 4315, 4030, and 4342, which were found lying atop the seabed, have lost a majority of their original surface and dimensions. There was only one coin (no.4325) with any significant amount of concretion; the deposits consisted of sand-sized to pebble-sized sedimentary particles and small shells bound together by calcareous concretion (see Figure 2). Coins 4325, 4331, 4324, and 4327 all have considerable amounts of iron corrosion products on their surfaces. Since these coins represent valuable components of Peruvian, Spanish and Portuguese cultural heritage, a non-invasive methodology of surface analysis was chosen.

Figure 2: Obverse surface of coin no 4325 on the left and reverse on the right.

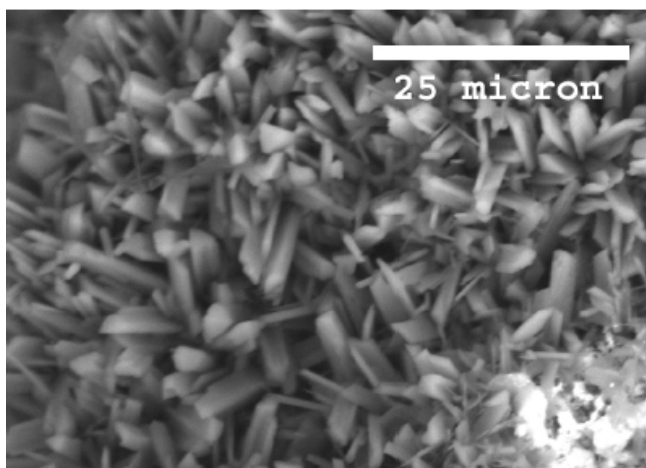
Calcium carbonate was abundant on every coin surface either as biogenic deposits or as inorganic crystals of magnesian calcite, (Ca_{1-x}Mg_xCO₃) while the polymorph magnesian aragonite was found covering large areas of coin 4327. The aragonite is in a steep pyramidal form as clusters of sharp spiked crystals (see Figure 3) The presence of this form of aragonite on coin 4327 indicates that this coin was subjected to a different microenvironment. In normal seawater of salinity 34.33% the ionic product of calcium and carbonate ions at pH 8.2 is 270 x 10⁻⁸, which is much higher than the solubility product of 50 x 10⁻⁸ for calcium carbonate, confirms that seawater is supersaturated with respect to calcium carbonate (Horne, 1969). Any change in temperature,

Figure 3: Field of magnesian aragonite on surface of coin no. 4327, full width 68 μm

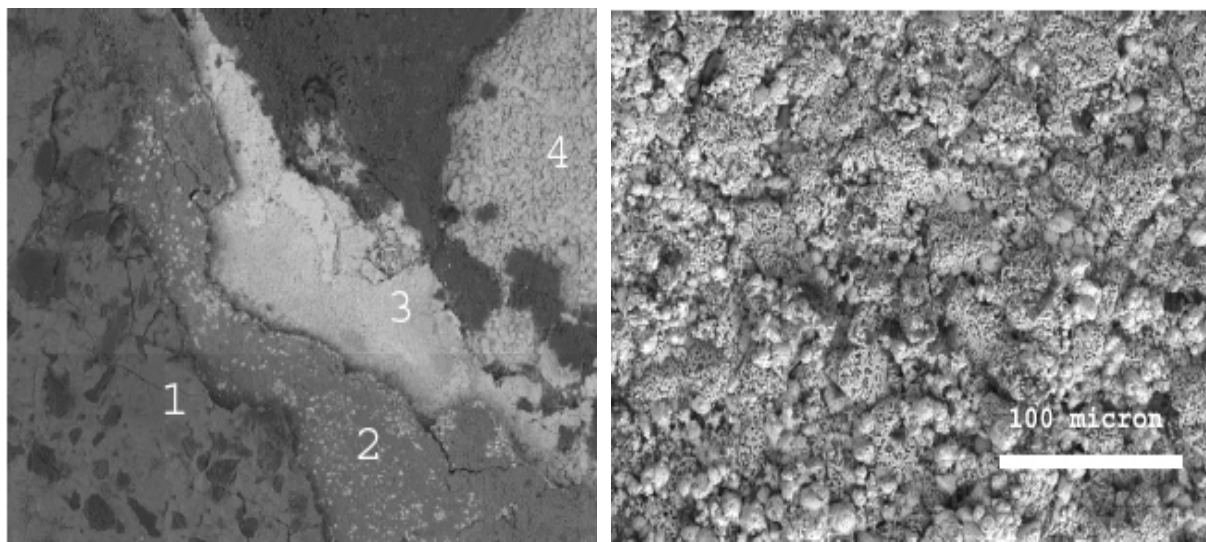
The large amounts of iron found in the concretions and as distinct films on the coins recovered from a buried microenvironment is consistent with the history of the site. The majority of the surfaces of coins 4325, 4327, and 4331 were covered with a layer of pure hydrated iron oxides, such as $\text{FeOOH}\cdot x\text{H}_2\text{O}$. The films are compact and of relatively uniform thickness. The deposition of this material is likely to have occurred during the salvaging of the *João Diogo* as a continuous film that was subsequently eroded/corroded away in areas to reveal underlying layers of silver halides. The absence of iron on coins 4315, 4030 and 4342 is a reflection that these coins are highly eroded and corroded and have very little concretion.

Redeposited silver is present on coins 4324, 4342, and 4325 as crystals that have grown on top of the crystalline primary corrosion products and on top of amorphous deposits. The exposed silver sulphide stratum underneath the iron film on coin 4325 exhibits numerous inclusions of redeposited silver crystals averaging 15 microns in length (see Figure 4). Redeposited silver crystals are commonly found underneath iron oxide films on silver coins from marine shipwrecks in Australia (MacLeod, 1991). The formation of silver crystals can be due to the poor electrical and ionic conduction properties of iron oxide films, which can limit oxygen access to the corroding metal surface and favours alternative reduction reactions such as

Figure 4: Left SEM photomosaic of coin 4325 showing layer 1: (lower left) hydrated iron oxides with silica inclusions, layer 2: mixed silver and copper halides, layer 3: silver sulphides, layer 4: silver halides overlaying the dark grey CaCO₃ deposits (image width 1100 µm). The right SEM image shows corroded redeposited silver intermixed with silver halides, width 800 µm,

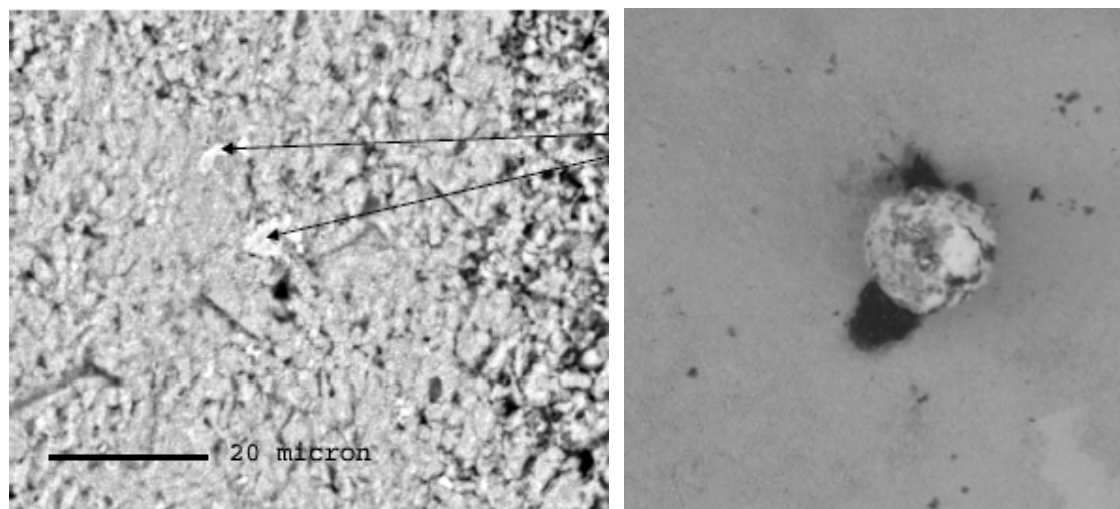
The spherical shape of these deposits is attributed to the high surface tension of mercury and alludes to drops of mercury sitting on the surface of the coins and amalgamating the underlying primary silver. Relatively large non-spherical deposits of 1:1 amalgam are present on coins 4342, 4315, and 4030. The edges of the amalgam deposits on all of these coins are rounded hinting at the influence of surface tension on their formation. The obverse of 4030 is covered with a discontinuous layer of amalgam that contains large amounts of silicon inclusions. This coin may have at one time been sitting in a pool of mercury on the site. In addition to the amalgam on these coins, an anomalous non-spherical deposit of virtually pure mercury sits on top of an

Ag(Cl,Br) matrix on the obverse of coin 4342 The failure of the amalgam formation is likely to be due to the deposition of a siliceous organism on the coin surface which acts as an insulator.

Figure 5: The left image shows the BSE images of obverse of coin no 4342, of silver amalgam (arrowed) in a silver halide matrix (image width 70 μm), right BSE image showing an amalgam sphere on coin 4342, approximate diameter 110 μm .

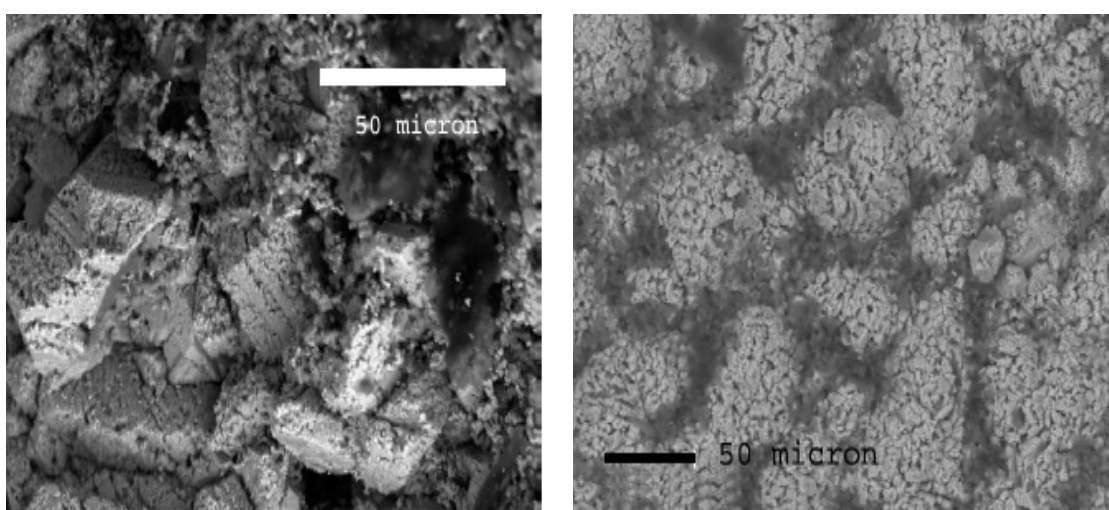
The major silver corrosion product found on every coin in this study is embolite Ag(Cl,Br), otherwise known as bromian chlorargyrite, with minor amounts of chlorargyrite (AgCl). The presence of these minerals is to be expected given the coins are from a shallow and energetic ocean site. Bromian chlorargyrite has been found in quantity on archaeological silver artefacts from both terrestrial and underwater environments. Since the silver ion concentration needed to precipitate AgCl from seawater is 2.92×10^{-10} and for AgBr it is 5.04×10^{-10} the coprecipitation of both halides is not unexpected. Kolthoff and Yutzy, Hedges (1976) speculated that the ratio of bromide to chloride in silver halide corrosion products from a marine environment would be on the order of 0.33 on a molar basis and analysis of a Spanish piece of eight found a similar ratio. Coins from the *San Pedro De Alcantara* site had molar ratios of bromine to chlorine in chlorargyrite from 0 to 1.0 on a molar basis, with the mode ratio being 1.0. There are two distinct phases of bromian chlorargyrite on all of the coins: amorphous particles that occur as pavements and larger isometric crystals. Except for the heavily eroded coins (4315, 4030, 4342), the coins display pavements of amorphous particles overlying a stratum of large Ag(Cl,Br) crystals measuring up to 50 microns. The large crystals are lamellar in structure and appear to be the product of recrystallisation (see Figure 6). EDS analysis of the two phases revealed no difference of Cl:Br ratios between them. Cubic crystals of chlorargyrite are present on the coins in limited quantity and were usually found intermixed with the amorphous Ag(Cl,Br) pavements. Bromargyrite (AgBr) was not observed on any of the coins in this study.

Figure 6: Left BSE micrograph of coin 4331 showing lamellar structure of large Ag(Cl,Br) crystals, image width 140 μm and the right image from the reverse of coin 4325 showing crystals in the process of recrystallising, image width 300 μm

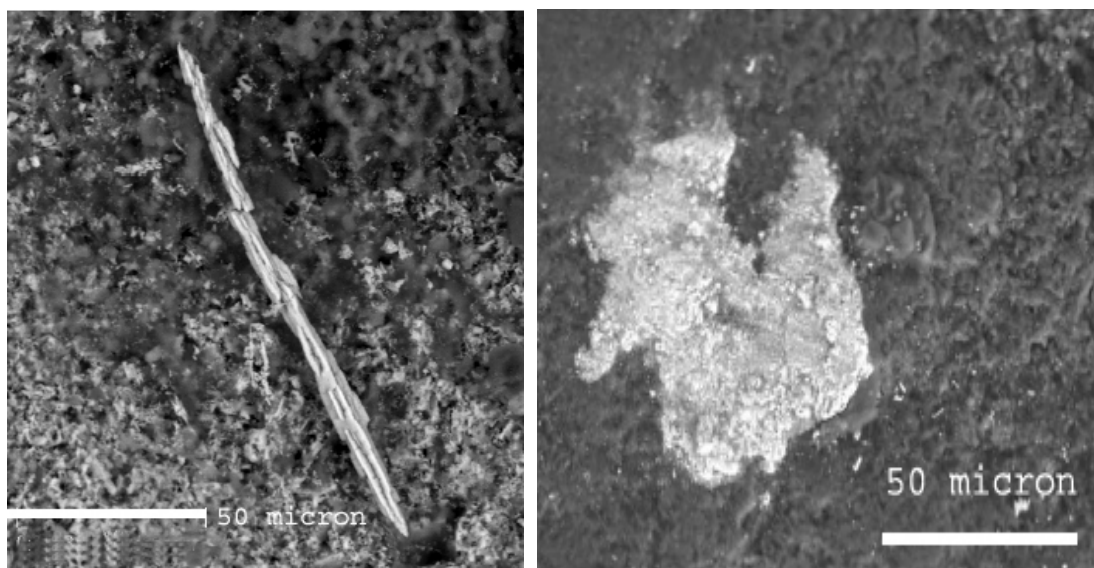
Figure 7: Left BSE image of the reverse surface of coin no 4030 showing an anglesite crystal, image width 140 μm and on the right, an image from the obverse of the same coin on the obverse showing laurionite in a calcium carbonate matrix, width of 110 μm

Many anglesite (PbSO_4) crystals were found on the surface of coin 4030 along with deposits of laurionite (PbClOH) in the iron-bearing calcium carbonate concretions. Anglesite crystals covering the enormous range of 2-200 μm in length were found on both faces of the coin and have a tabular bladed appearance dominated by large pinacoid faces (see Figure 7). Most of the anglesite was found sitting on top of or intermixed with loose sand debris and calcite crystals in the niches of calcareous concretions. Laurionite was found as discrete amorphous deposits in the iron-bearing calcareous concretions on the obverse of this coin, mainly on the concretion edges. Coin 4030 is the only coin of the seven that bears lead minerals. Although it was not found near any lead artefacts, it could be postulated that the coin was at one time in close association with lead since both minerals are highly insoluble in seawater. Large crystals of calcium sulphate (CaSO_4) present on coins 4324, 4327, and 4331 are a likely consequence of iron corrosion products acting as ion exchange sites, which regularly concentrates sulphate ions so that the normally soluble minerals would precipitate on the coin surfaces.

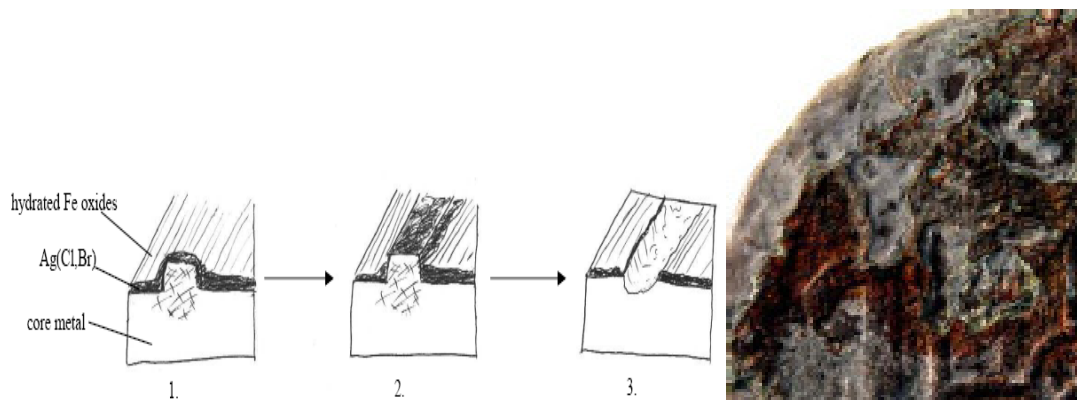
An unusual erosion corrosion phenomenon is found on many of the coins where the iron oxide films or thin calcareous concretions that were covering the raised lettering and design have worn away. In most of these areas there is only a hole that perfectly conforms to the shape of the eroded and corroded away raised design surrounded by an iron oxide film or concretion. The formation of these negative concavities most likely involved multiple steps, as indicated in Figure 8 for coin 4327, with the initial step involving the selective erosion of the topographical high points of the film or concretion.

Figure 8: Erosion corrosion mechanism for preferential deterioration of raised surfaces on coin 4327.

The likely second step involved the erosion corrosion of the softer and more conductive silver corrosion products that were exposed from step one. Due to the inherent stress (hatch marks in Figure 8) in the raised areas of the coins that was caused by cold-stamping, the raised points were probably corroded in preference to their surroundings

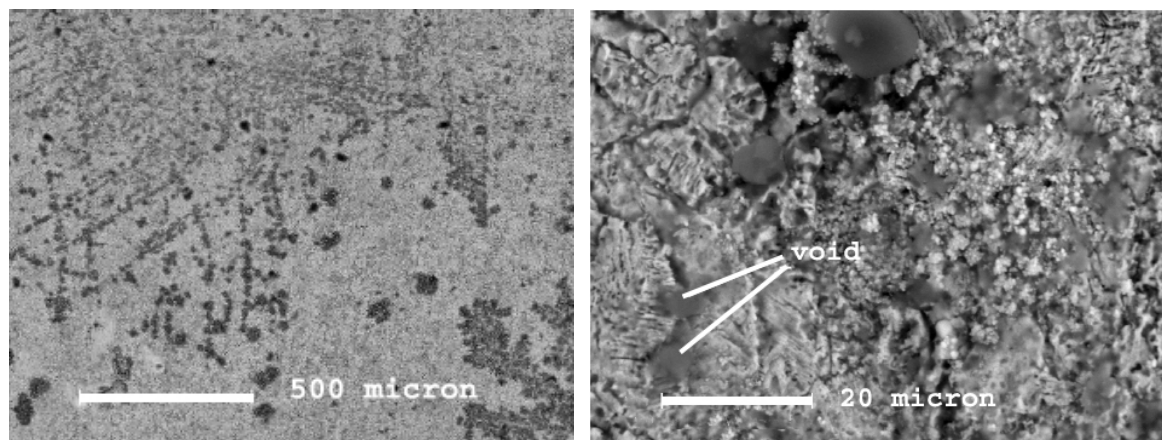
An example of stress related deterioration is seen on coin 4315, which exhibits strain lines on one edge of its obverse side (see left side of Figure 9). The strain lines, manifested by epitaxial copper (II) chloride growth in an amorphous Ag(Cl,Br) pavement, are evidence of residual stress caused during manufacture (Allen, 1969). The epitaxial growth of copper corrosion products is due to the fact that strain and slip lines can act as barriers for the migration of impurities in an alloy, causing these constituents to accumulate in those regions (Costa, 2001).

Figure 9: Left, BSE image from the obverse of coin 4315 showing Cu(II) chloride inclusions in an Ag(Cl,Br) pavement, image width 1650 μm , right image, the same surface showing exposed primary β silver grains, width of 80 μm .

The impurity in this case would be copper, given the room temperature solubility of copper in silver is only 0.1% (Butts, 1967). The precipitation of copper, usually along grain boundaries, from a solid silver-copper solution has been observed to occur on an archaeological time scale (Scott, 1991b). Additional evidence of manufacture is seen on the exposed core metal on the obverse of coin 4315, where the metallurgical grain structure is apparent, as seen in Figure 9. The microstructure of the coin was originally composed of a solid solution of β -phase grains with α -phase inclusions, which are now voids, in and surrounding the grains. This type of microstructure is characteristic of silver-copper alloys with copper contents between 5-10% (Costa, 2001). The absence of the α -phase (silver in copper) can be attributed to the selective corrosion of copper due to galvanic effects. Analysis of the area shown in the right hand image in Figure 9 showed it to consist of pure silver.
