The Leichhardt nameplate – a report on authenticity testing

David Hallam

Senior Conservator, National Museum of Australia

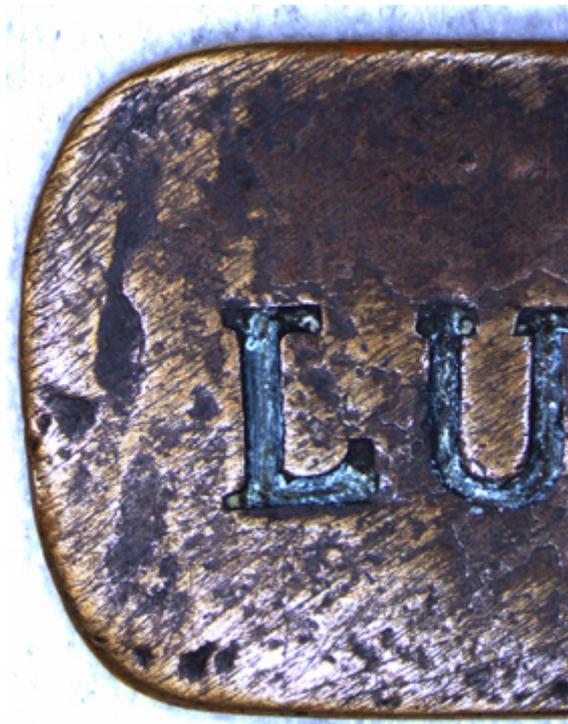
The base metal is 'yellow' in colour but covered with surface scratches, dents and oxides. Nowhere on the plate was a smooth flat surface observed. Reddish 'copper' metal overlays the yellow brass and in places it can be seen to be peeling from the substrate. Darker coloured patina is present on the lower areas of the surface. The surface was filed after it was stamped and engraved. The file marks and letters are corroded and have a deep patina.

View of the Leichhardt plate under the microscope. Photo: David Hallam.

The plate appears to be manufactured from recycled metal. The indentations in the end near the '48' are below the file marks, indicating this surface pre-dated the making of the plate (see photo above). It is a rough surface with indent marks from the forming process.

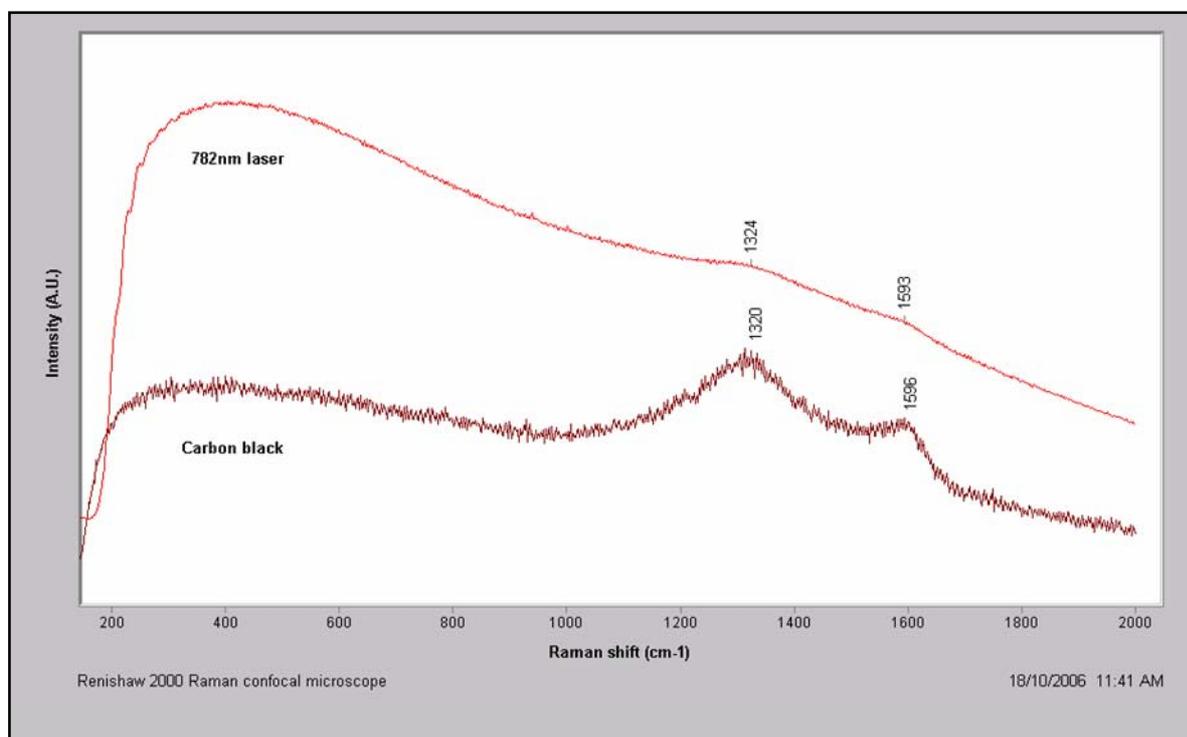
Figure 1 – Two Raman of carbon on the Leichhardt nameplate

Raman testing found colloidal carbon, which indicates exposure of the plate to a low temperature fire. This confirmed the SEM results. Titanium oxide was found by SEM to be present in the letters on top of carbon deposits. Raman confirmed this.

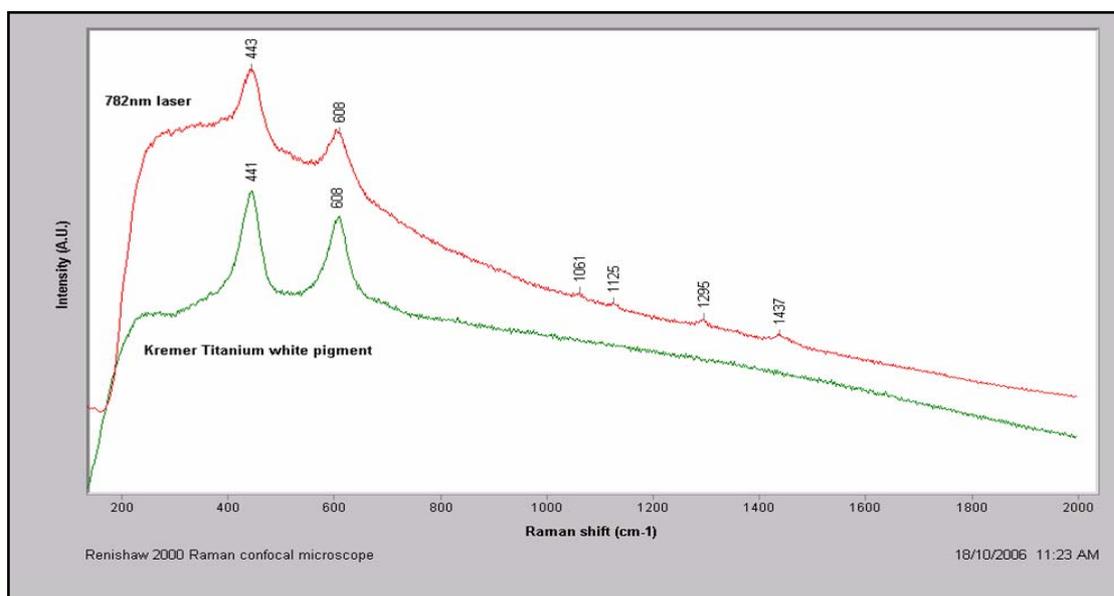
Figure 2 – TiO₂ Raman

The plate was found to have colloidal carbon in the letters. TiO₂ was verified in the letters. Other paint marks were analysed but have proved difficult to identify.
