The surface analysis of a brass plate

“LUDWIG LEICHHARDT 1848”

Assessment of authenticity

**Dr Ian D. MacLeod
Executive Director
Collections Management and Conservation
Western Australian Museum**

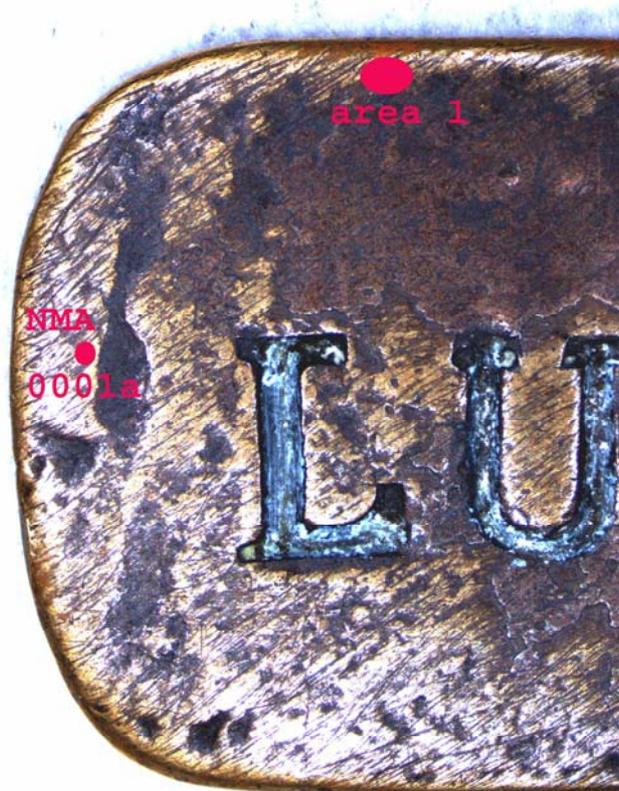
Figure 4: Photographic image of areas of spot analysis NMA001a and SEM image of area 1

The photographic image shown in Figure 4 illustrates the complex nature of the surface of the object, which has clearly defined transverse striations which are consistent with the metal

plaque having been somewhat crudely fashioned and finished with a flat file, with the scoring lines running approximately 45° to the horizontal plane. The detailed surface analysis was conducted at area NMA0001a since this zone seemed to be relatively free of corrosion products and the surface was relatively flat and was free from lettering impressions, and therefore free of localised stress associated with the manufacture of the plate. The area covered in the SEM image of this plate, area 1, was chosen to illustrate the general properties of this section of the plate which is characterised by an apparent upper surface layer on top of the lower section of brass. This area may represent a “lapping layer” which is characteristic of poor workmanship in the manufacture of brass and copper fastenings in the 19th century (MacLeod and Beng 2000, MacLeod and Pitrun 1988). The layering of the surface of the plaque is consistent with the metal having been produced by cold working and hammering of a different object, such as a brass sheathing nail or bolt, into a flat form. Evidence of the lack of a suitable heat treatment is seen in the ragged edges of the upper zones which overlie the underneath areas which have the lettering stamped into them. If the original form of the brass object was a square shank nail and if the maker of the plaque had hammered a square edge flat, the irregular edged layers would be consistent with what is seen on the surface of the plaque. Many of the defects seen on the plaque would not have been apparent to the fabricator or to the owner. The subtle surface differences would have become increasingly apparent as the impact of corrosion along the stress lines associated with the cold working became more pronounced.

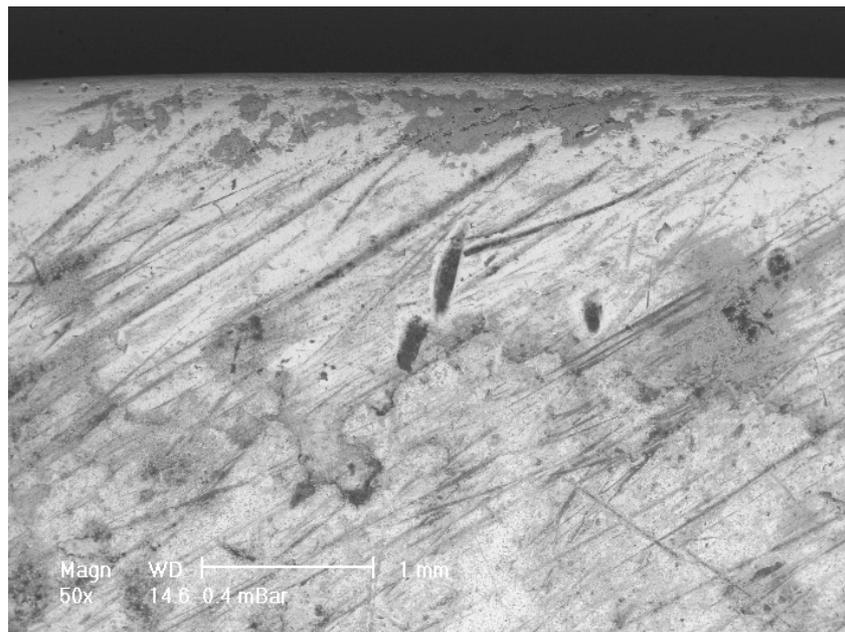
Figure 5: Backscattered SEM x 50 image of upper section of plaque at “LU” area 1 showing the morphological differences between the upper and lower section at the “join” between the two layers of metal.

The crusty deposit on top of the SEM image in Figure 5 is a layer of corrosion debris which also incorporates some elements of the archaeological deposit. The fact that the deposit has the same morphology as the gouges and scratch marks on the surface is consistent with the material having been naturally deposited on the surface i.e. not artificially formed. The next zone of the plaque that was examined was located above the letter “D”, area 2, and was characterized by an almost total lack of zinc; see Appendix I spot 3 for details, and was rich in copper, chloride and oxygen.

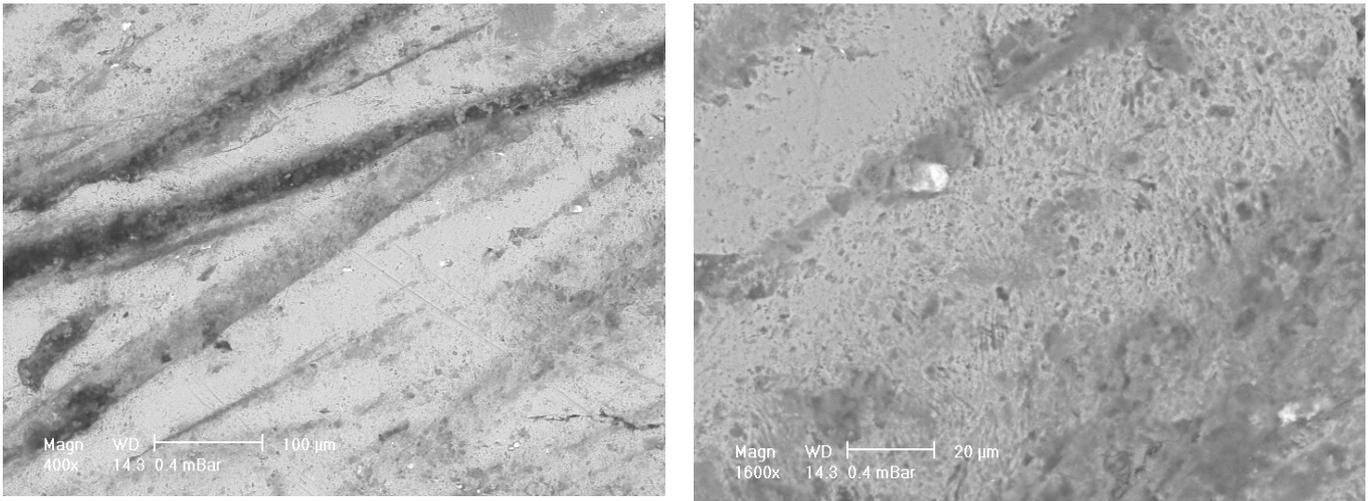
Figure 6: Left hand SEM image x 400 image of upper section of “LU” area showing elongated lead (bright grey) micro-droplets of lead and light weight mineral deposits in the grooved surfaces. Right hand image of the same object but at x 1600 showing a distorted lead inclusion and apparent sweat-induced corrosion in the middle of the image.

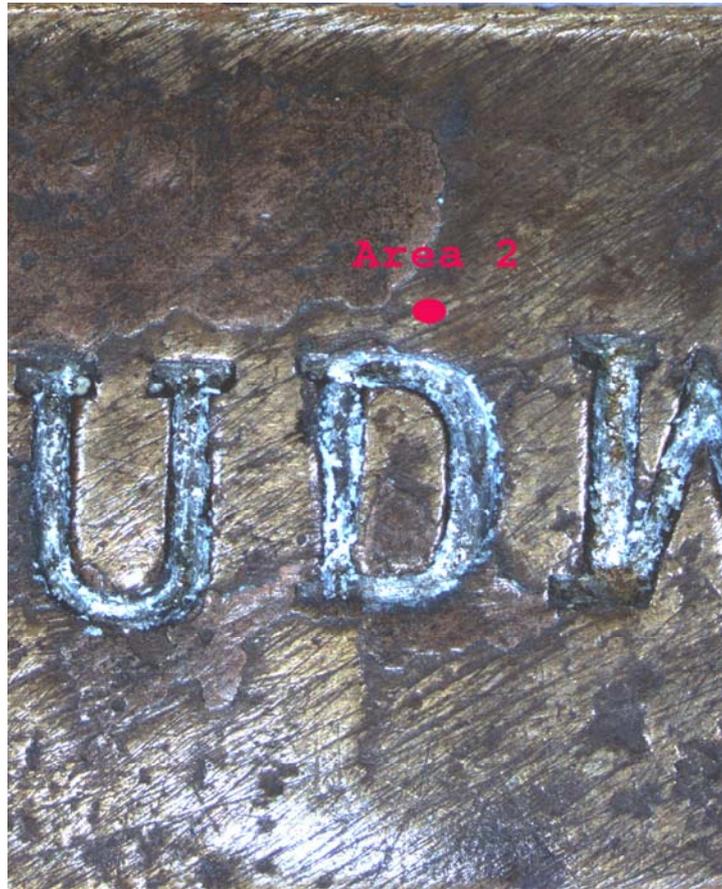
Figure 8: Optical image of the plaque at “UDW” area 2 of “LUDWIG • LEICHHARDT”

Spot analysis of the “lapped” area above the letter “D” shown in figure 8 is consistent with a primary oxidation layer of Cu_2O being on the surface which has a very low zinc content of 1.25 wt% - see Appendix 1 spot 4a. An area of localised corrosion near the letter “D” is shown in Figure 9 at x 50 and x 200 magnification. The dark spot is rich in low atomic weight elements such as carbon, which represents 49.2 wt% of the material, with a small amount of copper and less zinc. This is consistent with the corrosion matrix being a “copper spew” or a corrosion matrix that consists primarily of reaction products where copper has reacted with organic oils from fatty acids, such as found from repeated handling of an object. Since the copper (II) organic salts have a very different density and crystal structure to the underlying metal, they do not form a coherent coating on the surface and corrosion continues in the presence of moist air. The presence of chloride ions is consistent with the object being repeatedly handled and the earth elements of magnesium, calcium, silicon, potassium, iron and phosphorus are commonly associated with dirt and clay– see spot 004a in Appendix I.

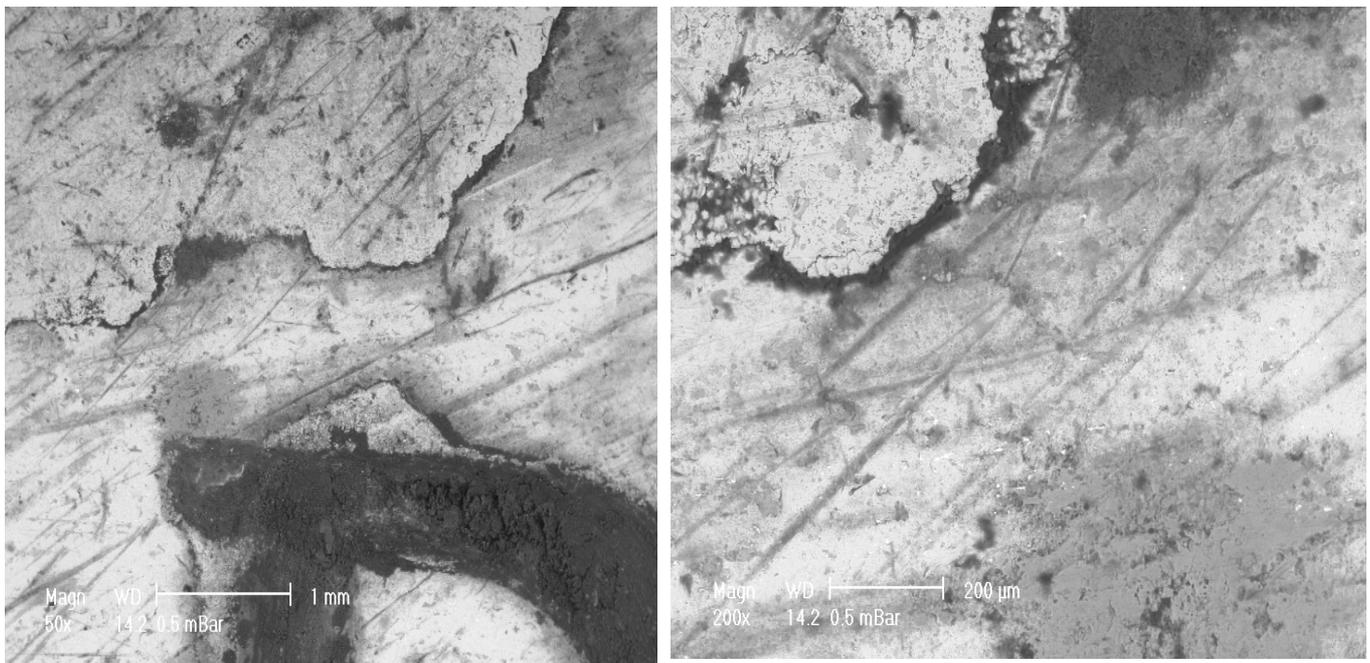
In the same area of the metal plate, there were also some very clearly defined sections of the surface where the main corrosion products were copper sulphides, with almost 12 wt% sulphur found at spot 004c, along with some chloride and only copper (no zinc) was present on the surface layers. The area of discussion is located in the lower right hand side of the higher resolution image in Figure 9 and is seen as a crusty mid grey crystalline deposit. The organic copper corrosion products are the dark grey phases at the edge of the interface between the lapped area, upper left side of the higher resolution image in Figure 9, and the body of the plaque.

Figure 9: SEM image x 50 (LHS) and x 200 (RHS) including the letter “D” on the plate.

It should be noted that there is a clearly defined crusty infill in the letter “D” which is characteristic of the use of a black shellac (carbon black mixed in with normal shellac or French Polish) which has suffered degradation from the effects of ultraviolet light and general exposure to humidity cycling. The clear separation of the copper sulphide phases from the general corrosion is seen in Figure 10, which shows the discrete corrosion areas at high magnification. The size of the corrosion zones is $20\pm 10\ \mu\text{m}$ and this is typical of the response of copper to the presence of small particles of sulphur, since bacterial colonies associated with production of sulphide ions from sulphate tend to be of the order $300\pm 150\ \mu\text{m}$ which are typical by-products of sulphate reducing bacteria. This form of localised corrosion is a characteristic of anaerobic bacterial metabolites reacting with copper based alloys or of direct chemical reaction of copper with sulphur (MacLeod 1993). The nature of the copper sulphide deposits, in terms of their distribution, morphology and size, supports an alternative source of sulphur than that coming from the metabolites of sulphate reducing bacteria, which reduce sulphate ions to sulphide ions.

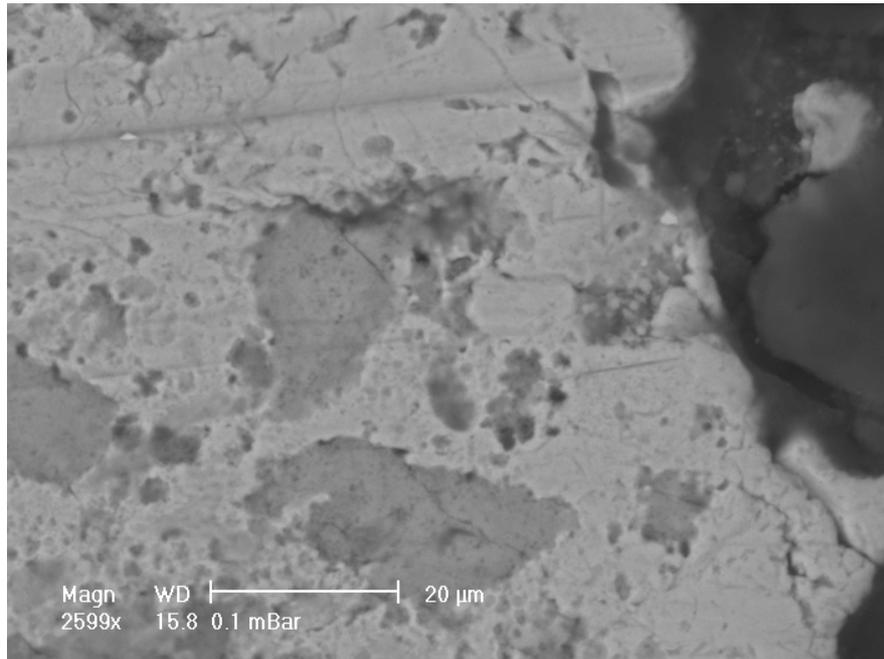
Figure 10: SEM x 2599 image of copper sulphide corrosion zones (mid grey) near letter “D”

The grain boundaries of the brass crystals can be seen in main copper sulphide deposit (see Figure 10 bottom midfield view) which seems to span three grains. It is possible that elemental sulphur fumes, thus very small particle size, resulting from the use of black powder as the rifle was fired, could have been absorbed from gun smoke. Typical composition of black powder had 10% charcoal, 10% sulphur and 80% potassium nitrate. In the event of such adsorption, the subsequent formation of copper sulphides is not unexpected and it is likely that sulphur fumes from spent black powder are the most likely source of sulphur on the brass plaque. Typical sizes of finely divided elemental sulphur used in the manufacture of gun powder are in the range of 10-6 μm , which is the same size as the primary copper sulphide corrosion products seen on the plaque.

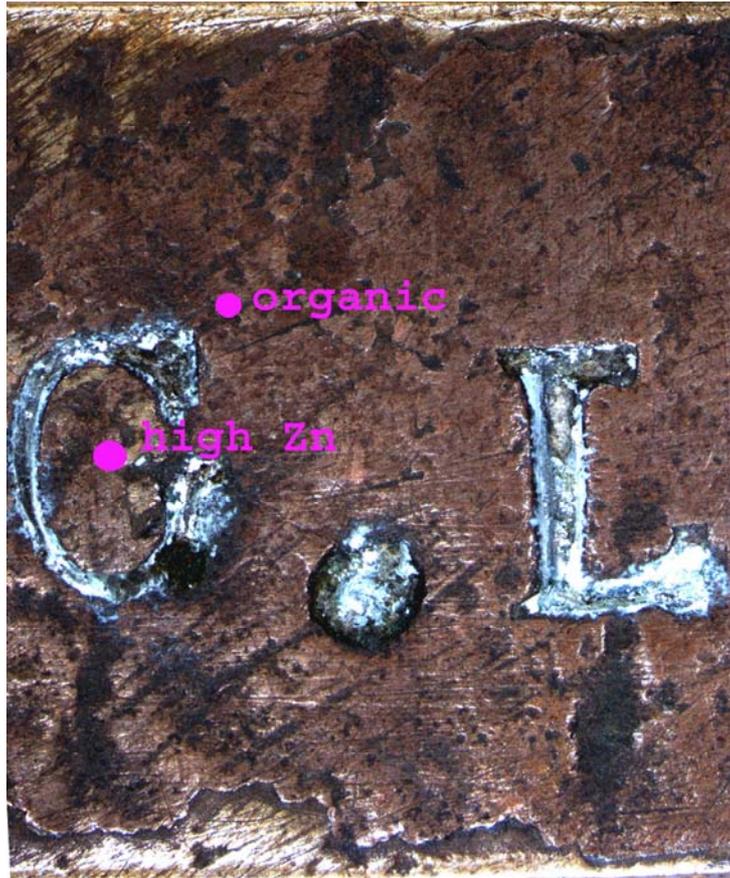
Figure 11: Optical image of the plaque at the separation of LUDWIG•LEICHHARDT showing overlapping layers of metal near the foot of the image and areas shown in the SEM Figure 12.

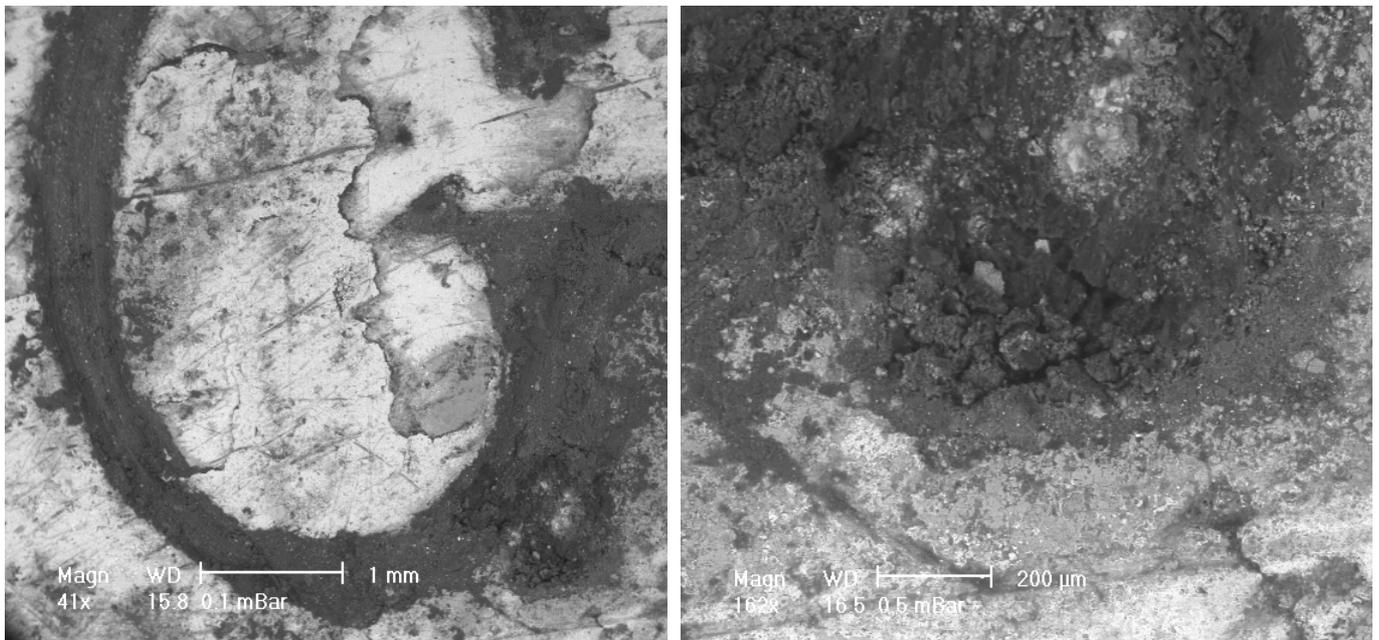
Figure 12: SEM surface details x 41 of the letter “G”. The right hand image x 162 is located near the bottom of the letter.

Four spot analyses of the dark deposits at the right hand side of the letter “G”, as shown in figure 12, showed that the corrosion deposits are dominated by organic copper corrosion products, see spot 006b in Appendix I. The content of the infill of “G” is essentially pure organic materials as shown in analyses 006a, 006c and 006d where the atomic ratios of carbon to copper are 52, 82 and 41 respectively. This is consistent with the material that produced the very dark grey SEM images being black shellac. Some intergranular corrosion below the letter “G” can be seen in the lower right hand side of the x 162 image in Figure 12. It should be noted that these surfaces also have high amounts of sulphur in them, with the maximum value of 8.57 wt % in sample 006c which has only 2.96 wt% copper and so there must be another source of sulphur other than copper sulphides. This sample area is also characterised by a high calcium content of 9.44 wt% which is consistent with some of the sulphur being present as gypsum or $\text{CaSO}_4 \cdot 2\text{H}_2\text{O}$. It is likely that calcium carbonate, CaCO_3 , is the most probable source of the additional calcium content of this area since evaporation of inland waters around lakes and soaks leads to precipitation of calcareous deposits.

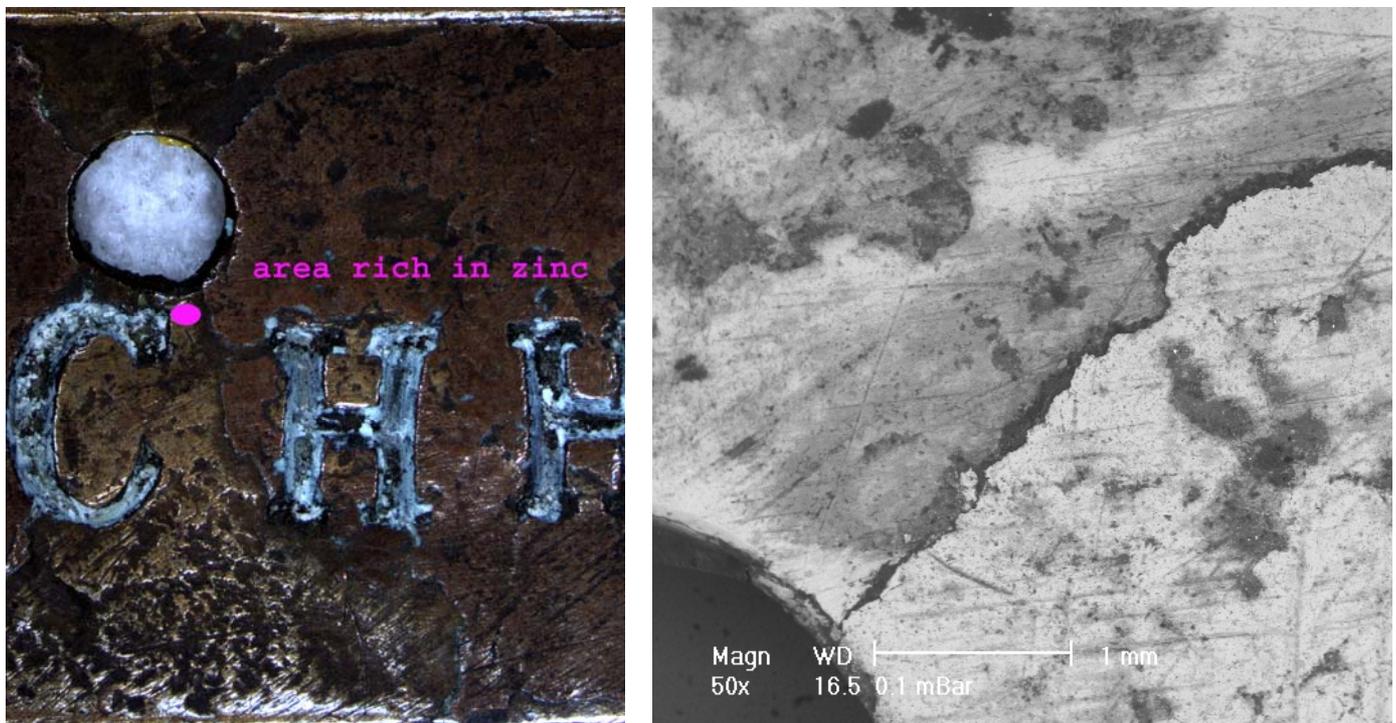
Selective corrosion of brasses can result in the “dezincification” of a surface where there has been mobilisation of zinc corrosion products away from the metal, which leaves the surface selectively enriched with copper i.e. the surface is depleted with regard to the underlying amount of zinc in the parent alloy. One of the underlying reasons why it is difficult to find large deposits of zinc corrosion products is that most zinc minerals, other than zinc sulphide, are quite soluble and will normally not be found on the surface of corroded brasses, certainly those found in a chloride rich environment. Although many areas of the plate have a copper enriched surface, some of the areas such as around the letter “C” near the hole, as shown in Figure 13, are characterised by a relatively high abundance of zinc and chloride.

Figure 13: Photograph of the plate showing the attachment hole and letters “CHH” and SEM images x 50 of zinc chloride rich corrosion near “C”

Although no X-ray diffraction was done on the surface, since no sampling was permitted, it is likely that the zinc chloride compounds on the surface could have included species such as simonkolleite, $Zn_5Cl_2(OH)_8 \cdot H_2O$ (Selwyn 2004). The presence of zinc hydroxy chlorides attests to the arid nature of the environment from which the object has presumably been sourced.

A more detailed examination of the surface area adjacent to the letter “C” of LEICHHARDT is shown in Figure 13 as the x 50 image, seen in the right hand side of the figure. The fissure relates to the lapping of the surfaces which relate to defects associated with the manufacture of the brass plaque, as previously noted. If the plaque had been formed by hot working of the original brass it is likely that the fusion bonding caused by hot hammering of the metal would have been disguised. Brass sections from infill a steam pipe from the wreck of the *Xantho* (1872), where inserts were formed by hot working, it was noted that the brass resisted any form of selective corrosion on the joining lines even after 130 years in seawater. The right hand side of the Figure 13 relates to an area of the plaque that is relatively uncorroded while the zone immediately to the left and lying above the fissure line has essentially no copper in it and is the zone where zinc chloride corrosion products dominate the EDAX analysis.

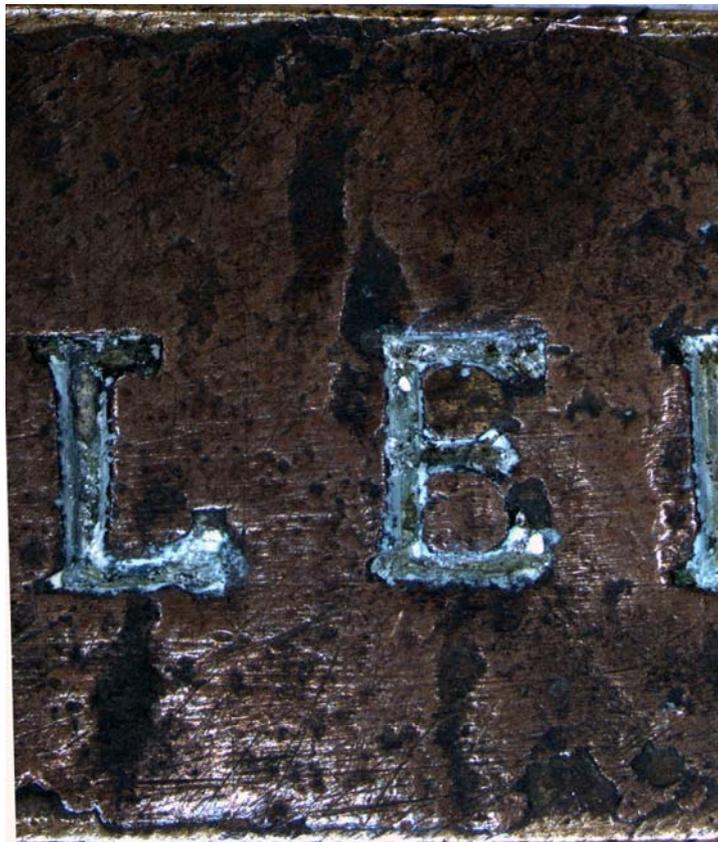
The lettering in the middle of the plaque, as seen in Figure 14, as the three leading letters of “LEICHHARDT” has little of the original infilling material present and the greatest amount of the white coloured infill material, which was originally thought to be polish residues. The greatest concentration of infill is seen in the foot of the letter “L” and in the lower right margins of the letter “E”, with a patch of the paint near the top of the letter.

Figure 14: Photographic image of the letters “LEI” showing presence of the white titanium based pigment inside the lettering, where the original black shellac has been lost.

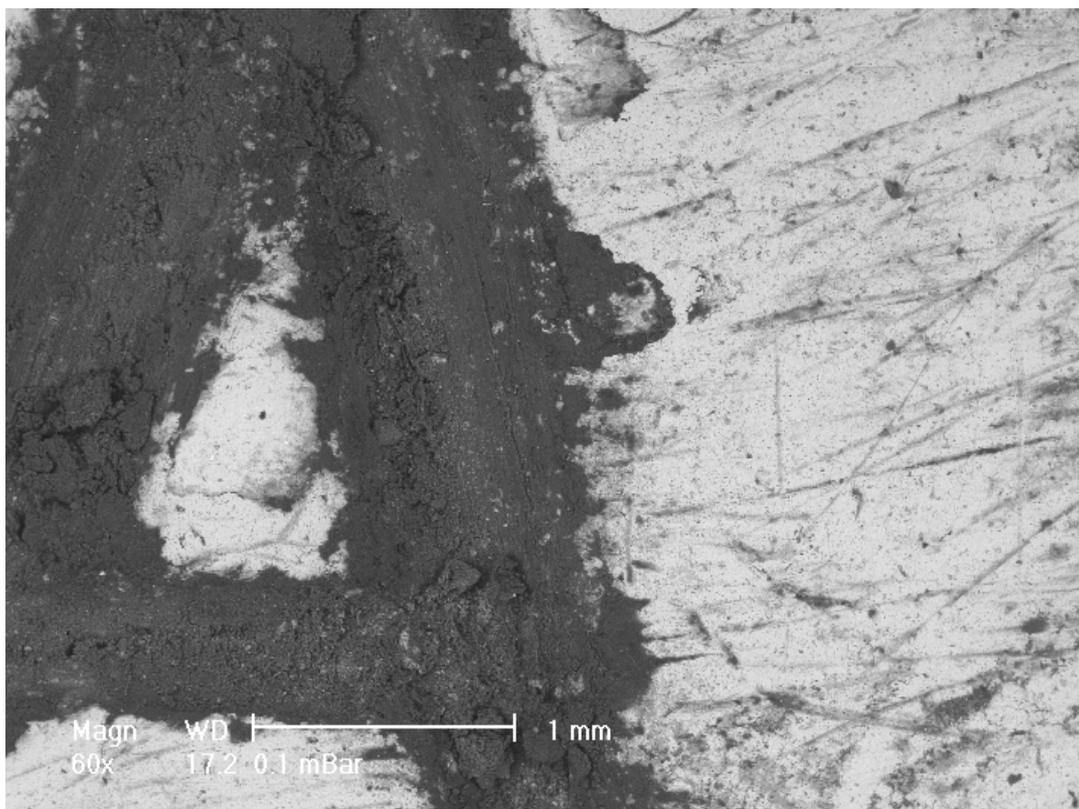
The last detailed analysis was conducted on the letter A of “LEICHHARDT” which still retained significant amounts of the original infilling of the lettering. The analysis of the infill was conducted in association with a mixture of phases present in the lettering. The analysis in spot 010b in Appendix I is consistent with the nature of oxidized black shellac. The nature of the white deposit alluded to in Figure 14 was determined by the EDAX analysis where there was a significant amount of titanium (3.91 wt %) present on the surface of the deposit. The most likely compound that is consistent with the nature of the analysis is a pigment based on titanium dioxide, TiO_2 , which is consistent with the highlighting the lettering with modern white paint – see Figure 15. Other elements present in this area of the lettering and associated with the materials deposited in the scoring associated with the coarse filing of the surface were significant amount of aluminium, silicon, potassium, calcium and some sulphur.

Figure 15: and x 60 letter “A” with in-filled lettering.

The origin of the sulphur is most likely associated with remnants of the use of black powder in the firing of the rifle while the presence of potassium, aluminium and silicon indicates clay like aluminosilicate minerals such as kaolinite. The calcium would normally be associated with gypsum, $\text{CaSO}_4 \cdot 2\text{H}_2\text{O}$ or some calcareous deposit such as calcite CaCO_3 . Rubbing the plaque with the earth and ash deposits from a bush campfire would leave behind residues which would be essentially identical to the materials that were observed on the plaque.

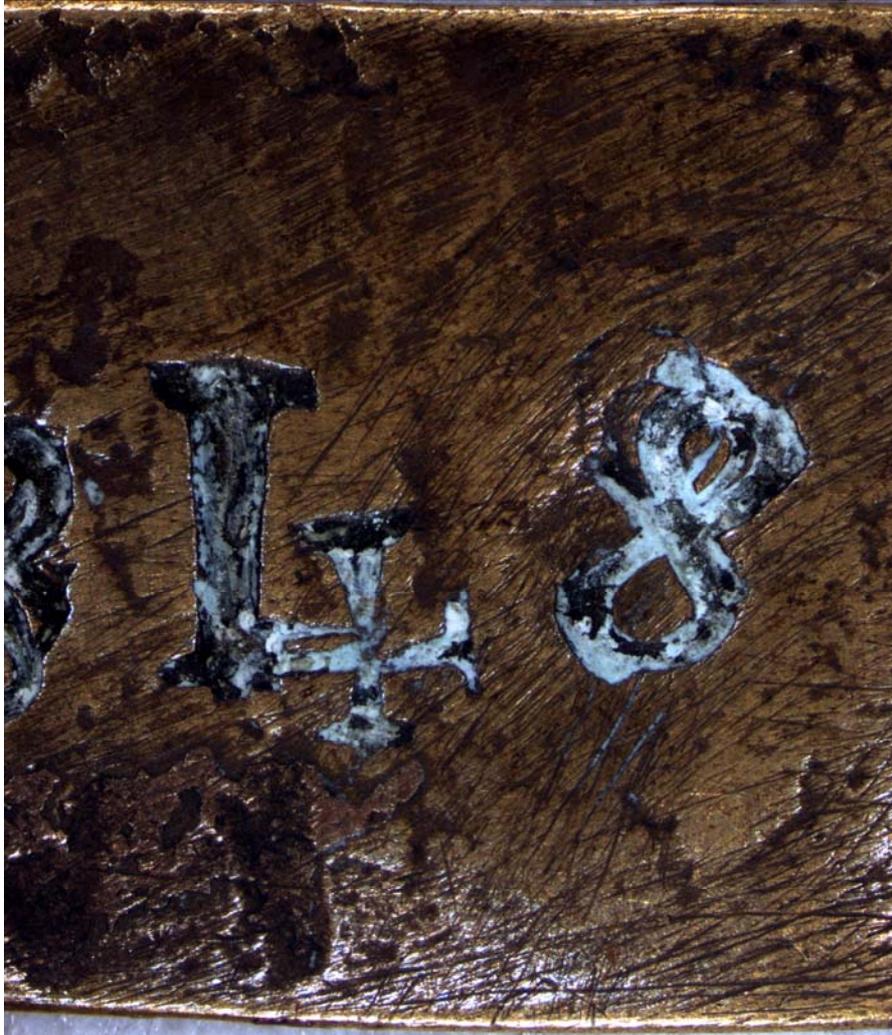
Inspection of the letters and numbers on the plaque indicates that there appears to have been some degree of difficulty associated with manufacturing the lettered plaque. Apart from the use of the upside down “M” instead of a “W” in “LUDWIG” and the number “4” is clearly a composite of the letter “I” and crossed tails of smaller letters to finish off the formation of the number.

Figure 16: Photographic image of the final date stamps “48” showing poorly formed “4” and a double strike on “8”.

Close to the right hand edge the final “8” of the “1848” date shows evidence in the upper section of the number of at least two attempts to successfully imprint the last number. The difficulty of punching the numbers close to the end of the plaque may well be a reflection of the cold working having produced a much harder brass that resisted the impact of the striking punch (MacLeod and Pitrun, 1988).
