## Corrosion monitoring and the environmental impact of decommissioned naval vessels as artificial reefs

### Abstract

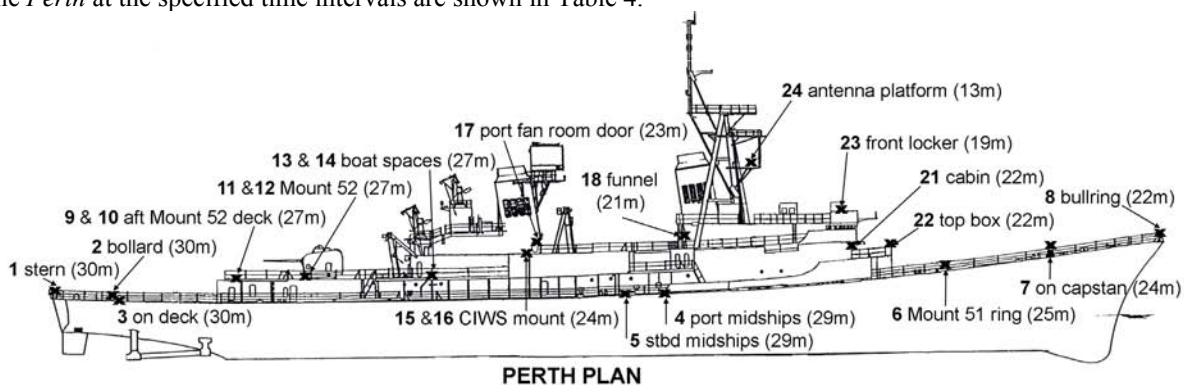
Figure 2. General arrangement plan of the HMAS *Perth* indicating the position of the 22 measuring points on the vessel.

The inaugural corrosion survey on the *Perth* was performed on 26 November 2001, two days after the scuttling then repeated after six months (199 days) and sixteen months (473 days) post-scuttling. The surface pH of the metal surfaces were not measured until the sixteen-month survey. The measuring point positions are shown diagrammatically on the general arrangement plan of the former HMAS *Perth* in Figure 2 and their positional descriptions outlined in Table 3. The measuring point positions, 19 and 20 were inadvertently cut out some time after attachment, prior to scuttling. The corrosion potential and surface pH of each point measured on the *Perth* at the specified time intervals are shown in Table 4.

Corrosion surveys of the *Hobart* were performed on 28 January 2003, two months (84 days) after the sinking and on 10 May 2003, six months (186 days) post-scuttling. The measuring point positions are almost identical to those of the *Perth* (Figure 2; Table 3) however, the Mount 51 gun on the main deck towards the bow of the *Hobart* remains intact. The corrosion potentials measured on the *Hobart* at the specified time intervals are shown in Table 5. No surface pHs of the metal surfaces have been measured to date.

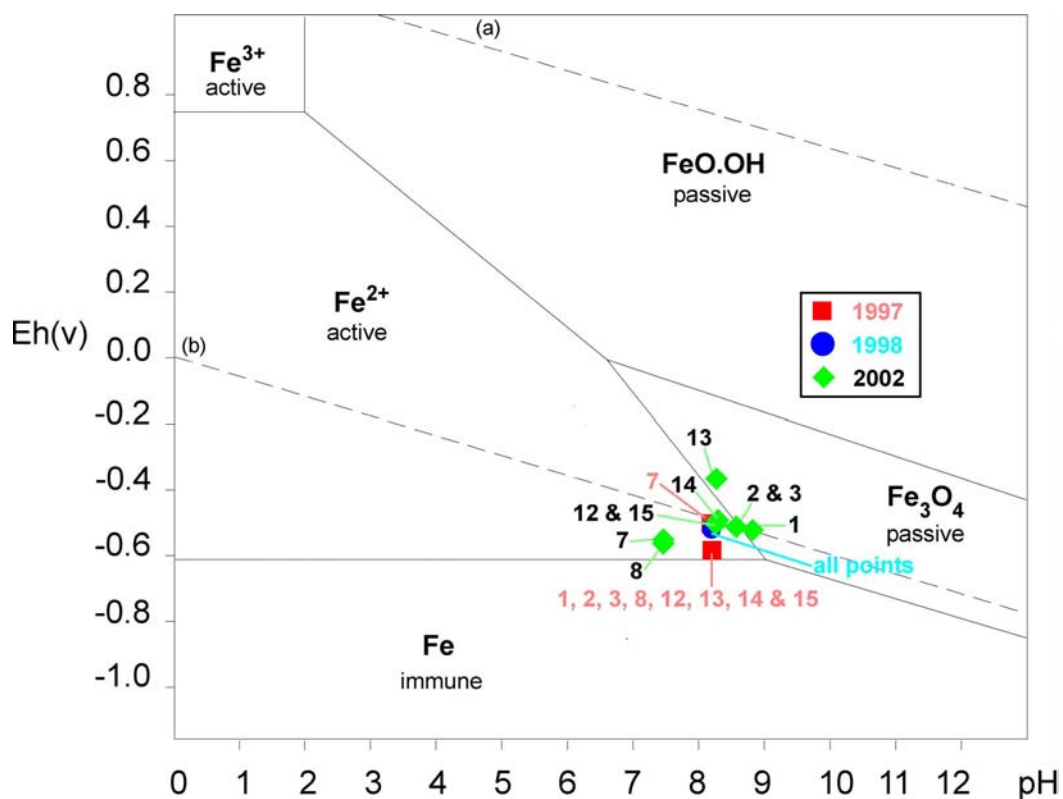
Figure 10. Iron ( $10^{-6}$ M) Pourbaix diagram in aerobic seawater at 25°C on the Swan after four years.

There were a significant number of discrete areas of aluminium corrosion products visible on the planar surfaces of each vessel's aluminium superstructure, which increased significantly with the time of immersion. Pitting and crevice corrosion are causing this deterioration of the aluminium as the protective paint system is slowly failing in these areas but it has not significantly affected the overall corrosion rates even after four years of submersion. These results signify that these contemporary vessels are corroding albeit at a relatively slow rate and this is most probably due to the protection afforded by the paint barrier remaining on the vessels. The monitoring programmes for the *Perth*, *Swan* and *Hobart* are the first systematic corrosion survey programmes established in Australia for monitoring the long-term stability of twentieth century warships after scuttling as artificial reefs. Complex corrosion behaviour are being exhibited by these vessels but it is still too early in the monitoring programmes to make any definitive statements regarding the long-term stability of these vessels.
