An approach to the conservation of deeply corroded archaeological silver: the *polos* from Crucinia

A. Archi Olsoufieff^a, O. Colacicchi Alessandri^b, M. Ferretti^{c*}

Keywords: polos, archaeological silver, conservation, gilding, corrosion, Crucinia Metaponto

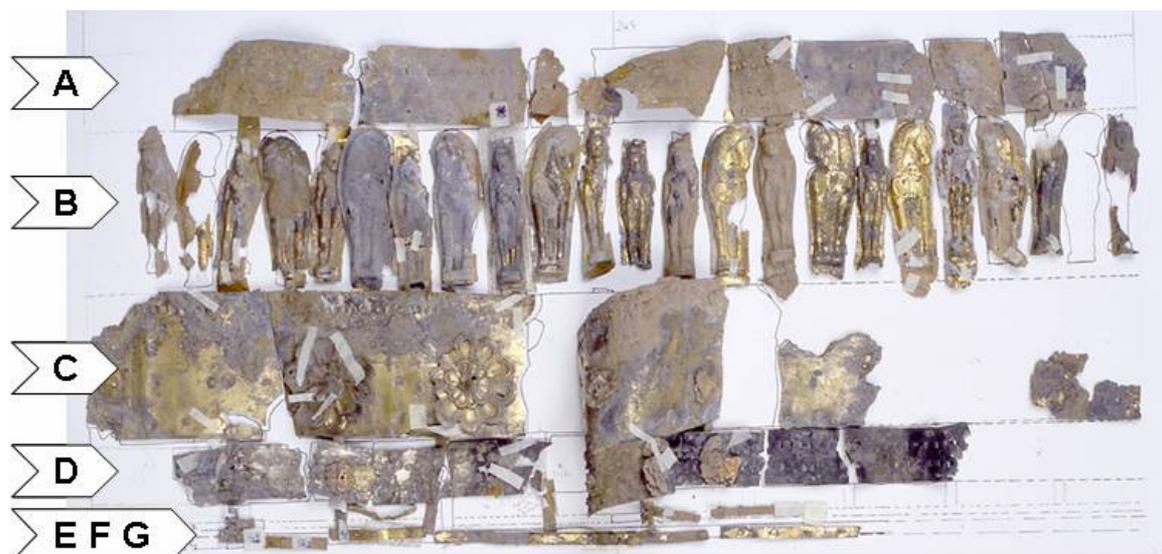
- photographic documentation of the material as received;
- sorting, visual identification and typological grouping of all the pieces, carried out with the aid of the poor pre-existing documentation. During these operations many connections among the fragments were found;
- establishment of an identification system related to the bands; these were identified with the letters A to G starting from the top (Figure 2).

Figure 2. First recombination of the polos resulting from the preliminary identification of the fragments (photograph by P. Rizzi).
