The surface analysis of a brass plate

“LUDWIG LEICHHARDT 1848”

Assessment of authenticity

**Dr Ian D. MacLeod
Executive Director
Collections Management and Conservation
Western Australian Museum**

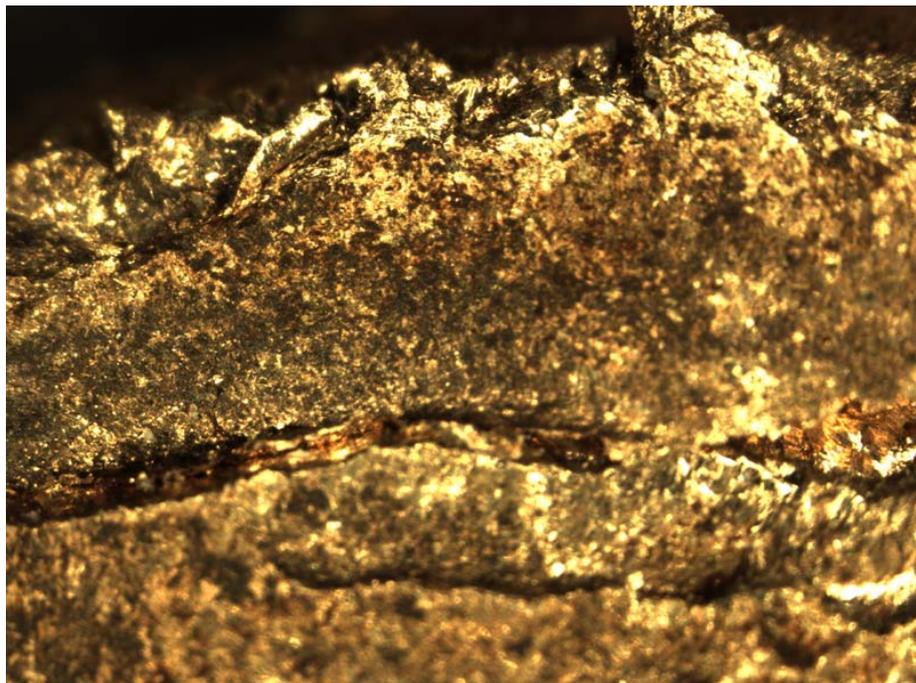
Support for the supposition that the plaque was manufactured from a square shank nail was obtained by experimenting with a 4 x 4 mm copper planking nail from an unidentified Western Australian shipwreck dated circa 1860. Repeated striking of the square edge with a 3 cm diameter head of an 800 g claw-hammer reduced the thickness to 2mm and the width increased to 10 mm. This reduction is very similar to that which would have produced the dimensional change in the lead micro-droplets in the plaque. After 40 blows the nail cracked and the hammered section fractured. Optical examination of the cold-worked surface showed the same characteristic ragged edge at the fold line that mimics the forms observed on the plaque and a 240 µm wide zone above it where the hammering did not effect fusion (see Figure 7).

Figure 7: Optical micrograph of cold worked 19th century copper nail full width 4.4 mm

Since brass is more ductile than the copper used in this experiment, the formation of the plaque through a similar hammering process is confirmed as being the most likely form of fabrication. The apparent loss of zinc from some surfaces is simply a reflection of localised corrosion processes. The formation of corrosion products on the surface means that minerals such as copper (II) hydroxy chlorides of the form $\text{Cu}_2(\text{OH})_3\text{Cl}$ as well as the normal dominant copper (I) oxide cuprite, Cu_2O would provide a reasonable explanation for the lack of zinc in the surface analysis. The surface analysis of the oxygen and chloride shows an atomic ratio of 3:1 which is consistent with the suggested chloride containing mineral (MacLeod, 1991).
