Analysis of some copper-alloy items from HMAV *Bounty* wrecked at Pitcairn Island in 1790.

Abstract

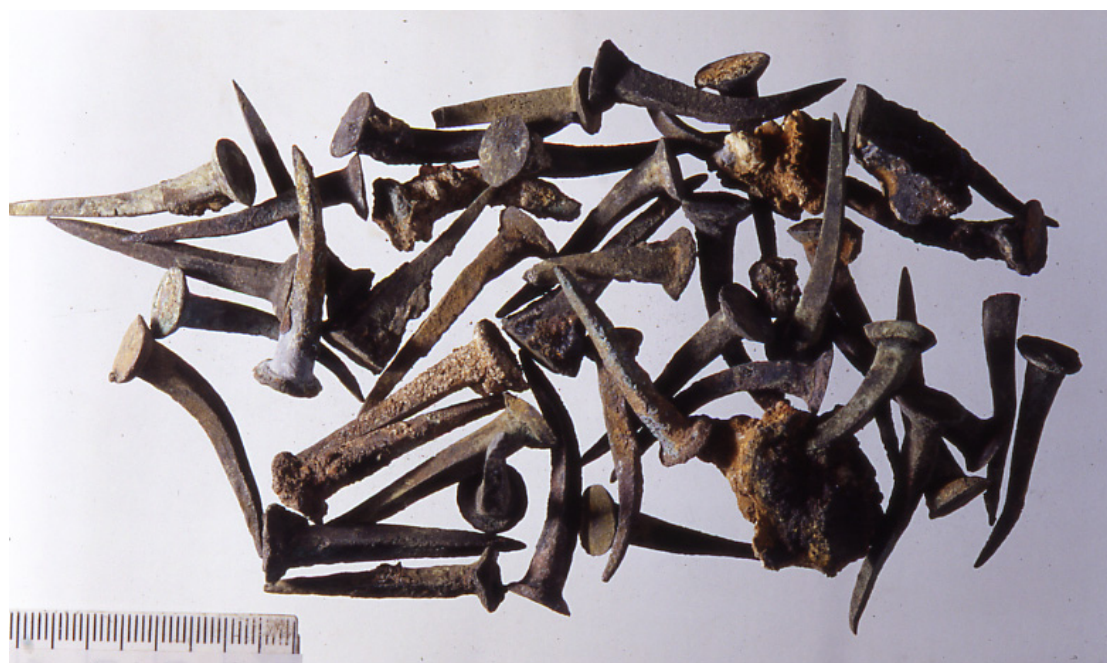
Figure 1: Nails with typological features described as common to *Bounty* assemblage (Scale in mm).

Although several copper alloy nails recovered from Adamstown sites appear to be *Bounty* nail types, a more positive identification of the nails is not possible without metallographic examination and chemical characterisation. Potentially the nails may also have originated from a number of other wrecks in the Pitcairn group: *Wildwave* (1858), *Cornwallis* (1875), *Khandeish* (1875), *Acadia* (1881), *Oregon* (1883), *Bowden* (1893) and *St James* (1918). Physically the *Bounty* maritime site sheathing nails appear curved from use, the common length is 40 mm with very slight variations and approximates to an imperial measurement of 1½ inches. The head of each nail is flat and round with a diameter of 10 mm and is conical under the head before forming a tapering, square-sectioned shank, ending in a sharp point. The physical uniformity of sheathing nails offers a potentially useful indicator of salvage and recycling of material from the *Bounty*.

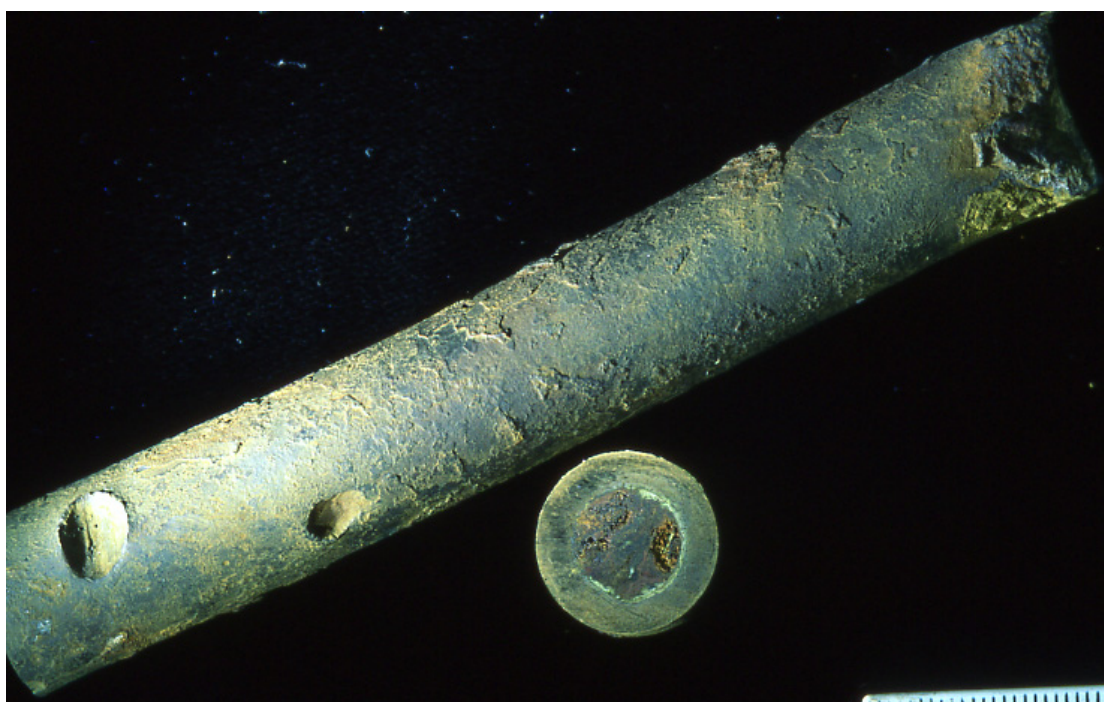
Figure 3: ZA 43 Sectioned pin (scale in mm)

Three of the composite objects recovered from the *Bounty* shipwreck site were sectioned for chemical and metallurgical analysis, though only two had remaining core metal (Table 3; Figure 3).

The core from ZA106 was significantly corroded and weight percentage analysis was not feasible. Analysis of the iron core in the two remaining samples ZA 98 and ZA 43 suggests that the cores were cast slugs with no subsequent work hardening. Visual observation of the corrosion evident in the remaining two pins shows corrosion more typical of cast iron than wrought. Within the iron core there were isolated pools of lead and tin as well as distributed copper with melt effects (Figure 4).
