## **SS *Great Britain* iron hull: modelling corrosion to define storage relative humidity**

**D. Watkinson<sup>a</sup>, M. Lewis<sup>b</sup>**

<sup>a,b</sup> Conservation Section, School of History and Archaeology, PO Box 909, Cardiff University, Cardiff, CF10 3XU, UK.

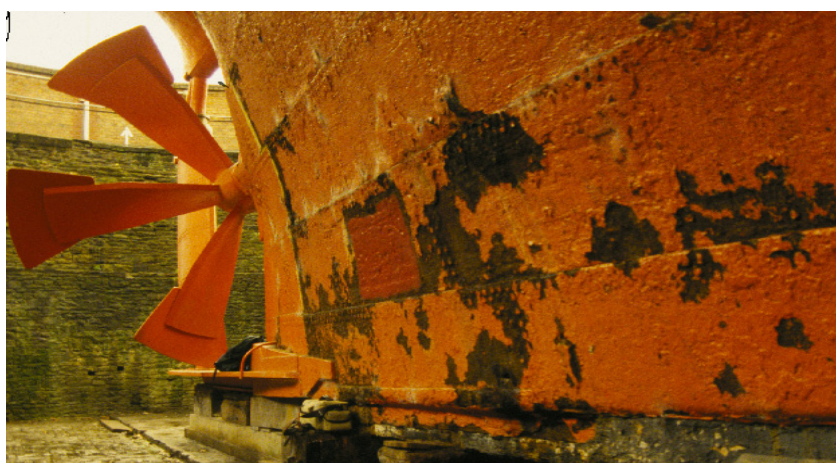
Figure 2. Ongoing corrosion of the ss *Great Britain* hull in dry dock.

Early conservation and maintenance of the hull had involved 10,000 psi aqueous pressure blasting and traditional shipyard practices that applied ‘protective’ coatings (Turner *et al* 1999). Understandably these measures failed to either stop corrosion or to appreciably slow its progress (Figure 2).

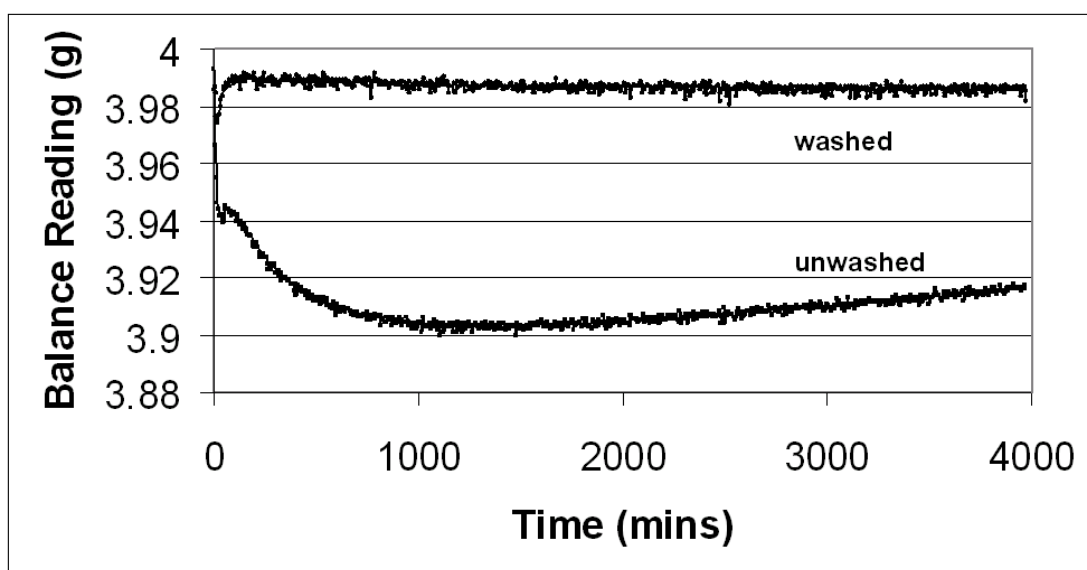
Figure 9. Washed  $\beta\text{FeOOH}$ /iron powder mixture exposed to 19% relative humidity, as compared to an unwashed sample of  $\beta\text{FeOOH}$ /iron powder.

A sample of washed  $\beta\text{FeOOH}$ /iron powder was exposed to 19% relative humidity. When compared to the unwashed sample at 19% relative humidity (Figure 7), it is clear that removal of surface chloride has eliminated the immediate aggressive corrosive effects of the  $\beta\text{FeOOH}$  on iron (Figure 9). The lack of weight loss by the sample may indicate that surface adsorbed chloride is responsible for the majority of the hygroscopic behaviour of  $\beta\text{FeOOH}$ . Our initial comments are that this may be due to the association of chloride with water and subsequent production of HCl on the surface of the  $\beta\text{FeOOH}$ , which then attracts water. Once chloride has been removed surface sites are occupied by hydroxyl ions from the wash solution. More research is required to investigate this theory.

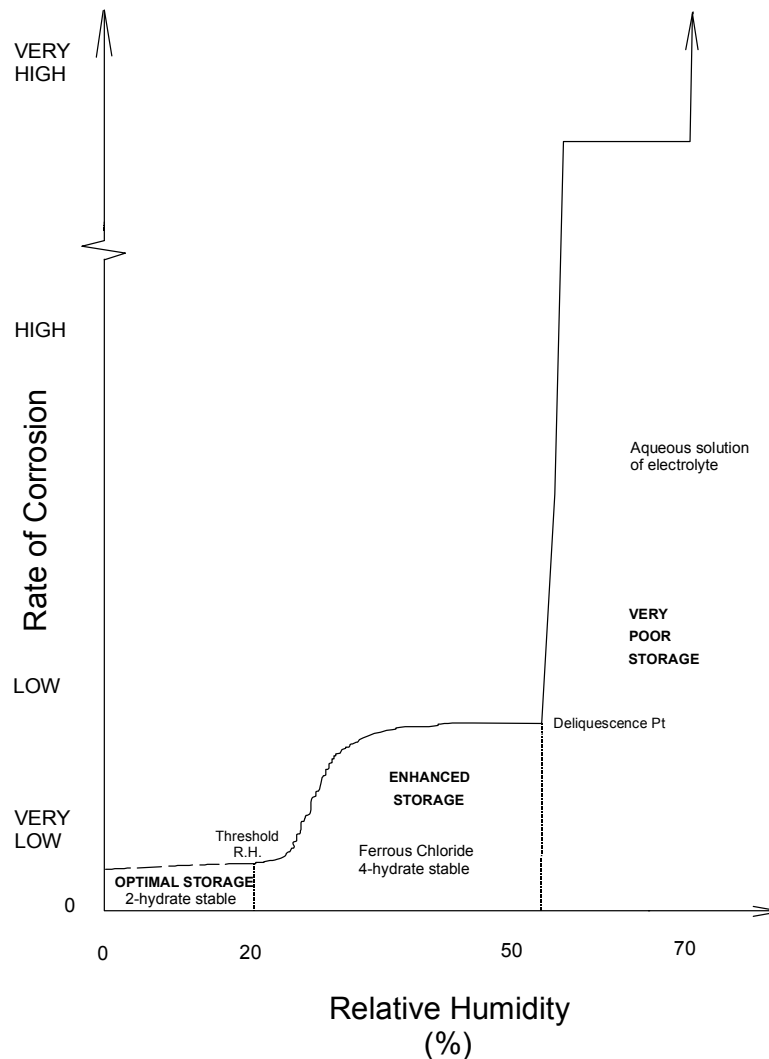
Figure 11. Schematic diagram of proposed corrosion rate/ relative humidity model.

Desiccating the 322 feet long hull of the ss *Great Britain* to 12% relative humidity would be costly and technically challenging, with potentially high maintenance costs. Examining the influence of  $\text{FeCl}_2 \cdot 4\text{H}_2\text{O}$  and  $\beta\text{FeOOH}$  on the rate of iron corrosion, as measured by the weight increases shown in Figures 6 - 8 indicates that corrosion is many times slower at 20% relative humidity, as compared to 25% or 30% relative humidity. It is worth taking a pragmatic view of the  $\beta\text{FeOOH}/\text{FeCl}_2 \cdot 4\text{H}_2\text{O}$  iron corrosion model and considering the overall effect of relative humidity on the rate of corrosion (Figure 11). The stability of the iron hull of the ss *Great Britain* could be significantly enhanced and its life-span prolonged by storage environments that control relative humidity to 20%.
